Exploration of origin and remediation of taste and odor issues associated with drinking water in Bucaramanga, Colombia.

Camilo Andres Rojas-Balli, William Burgos / Department Civil and Environmental Engineering / The Pennsylvania State University

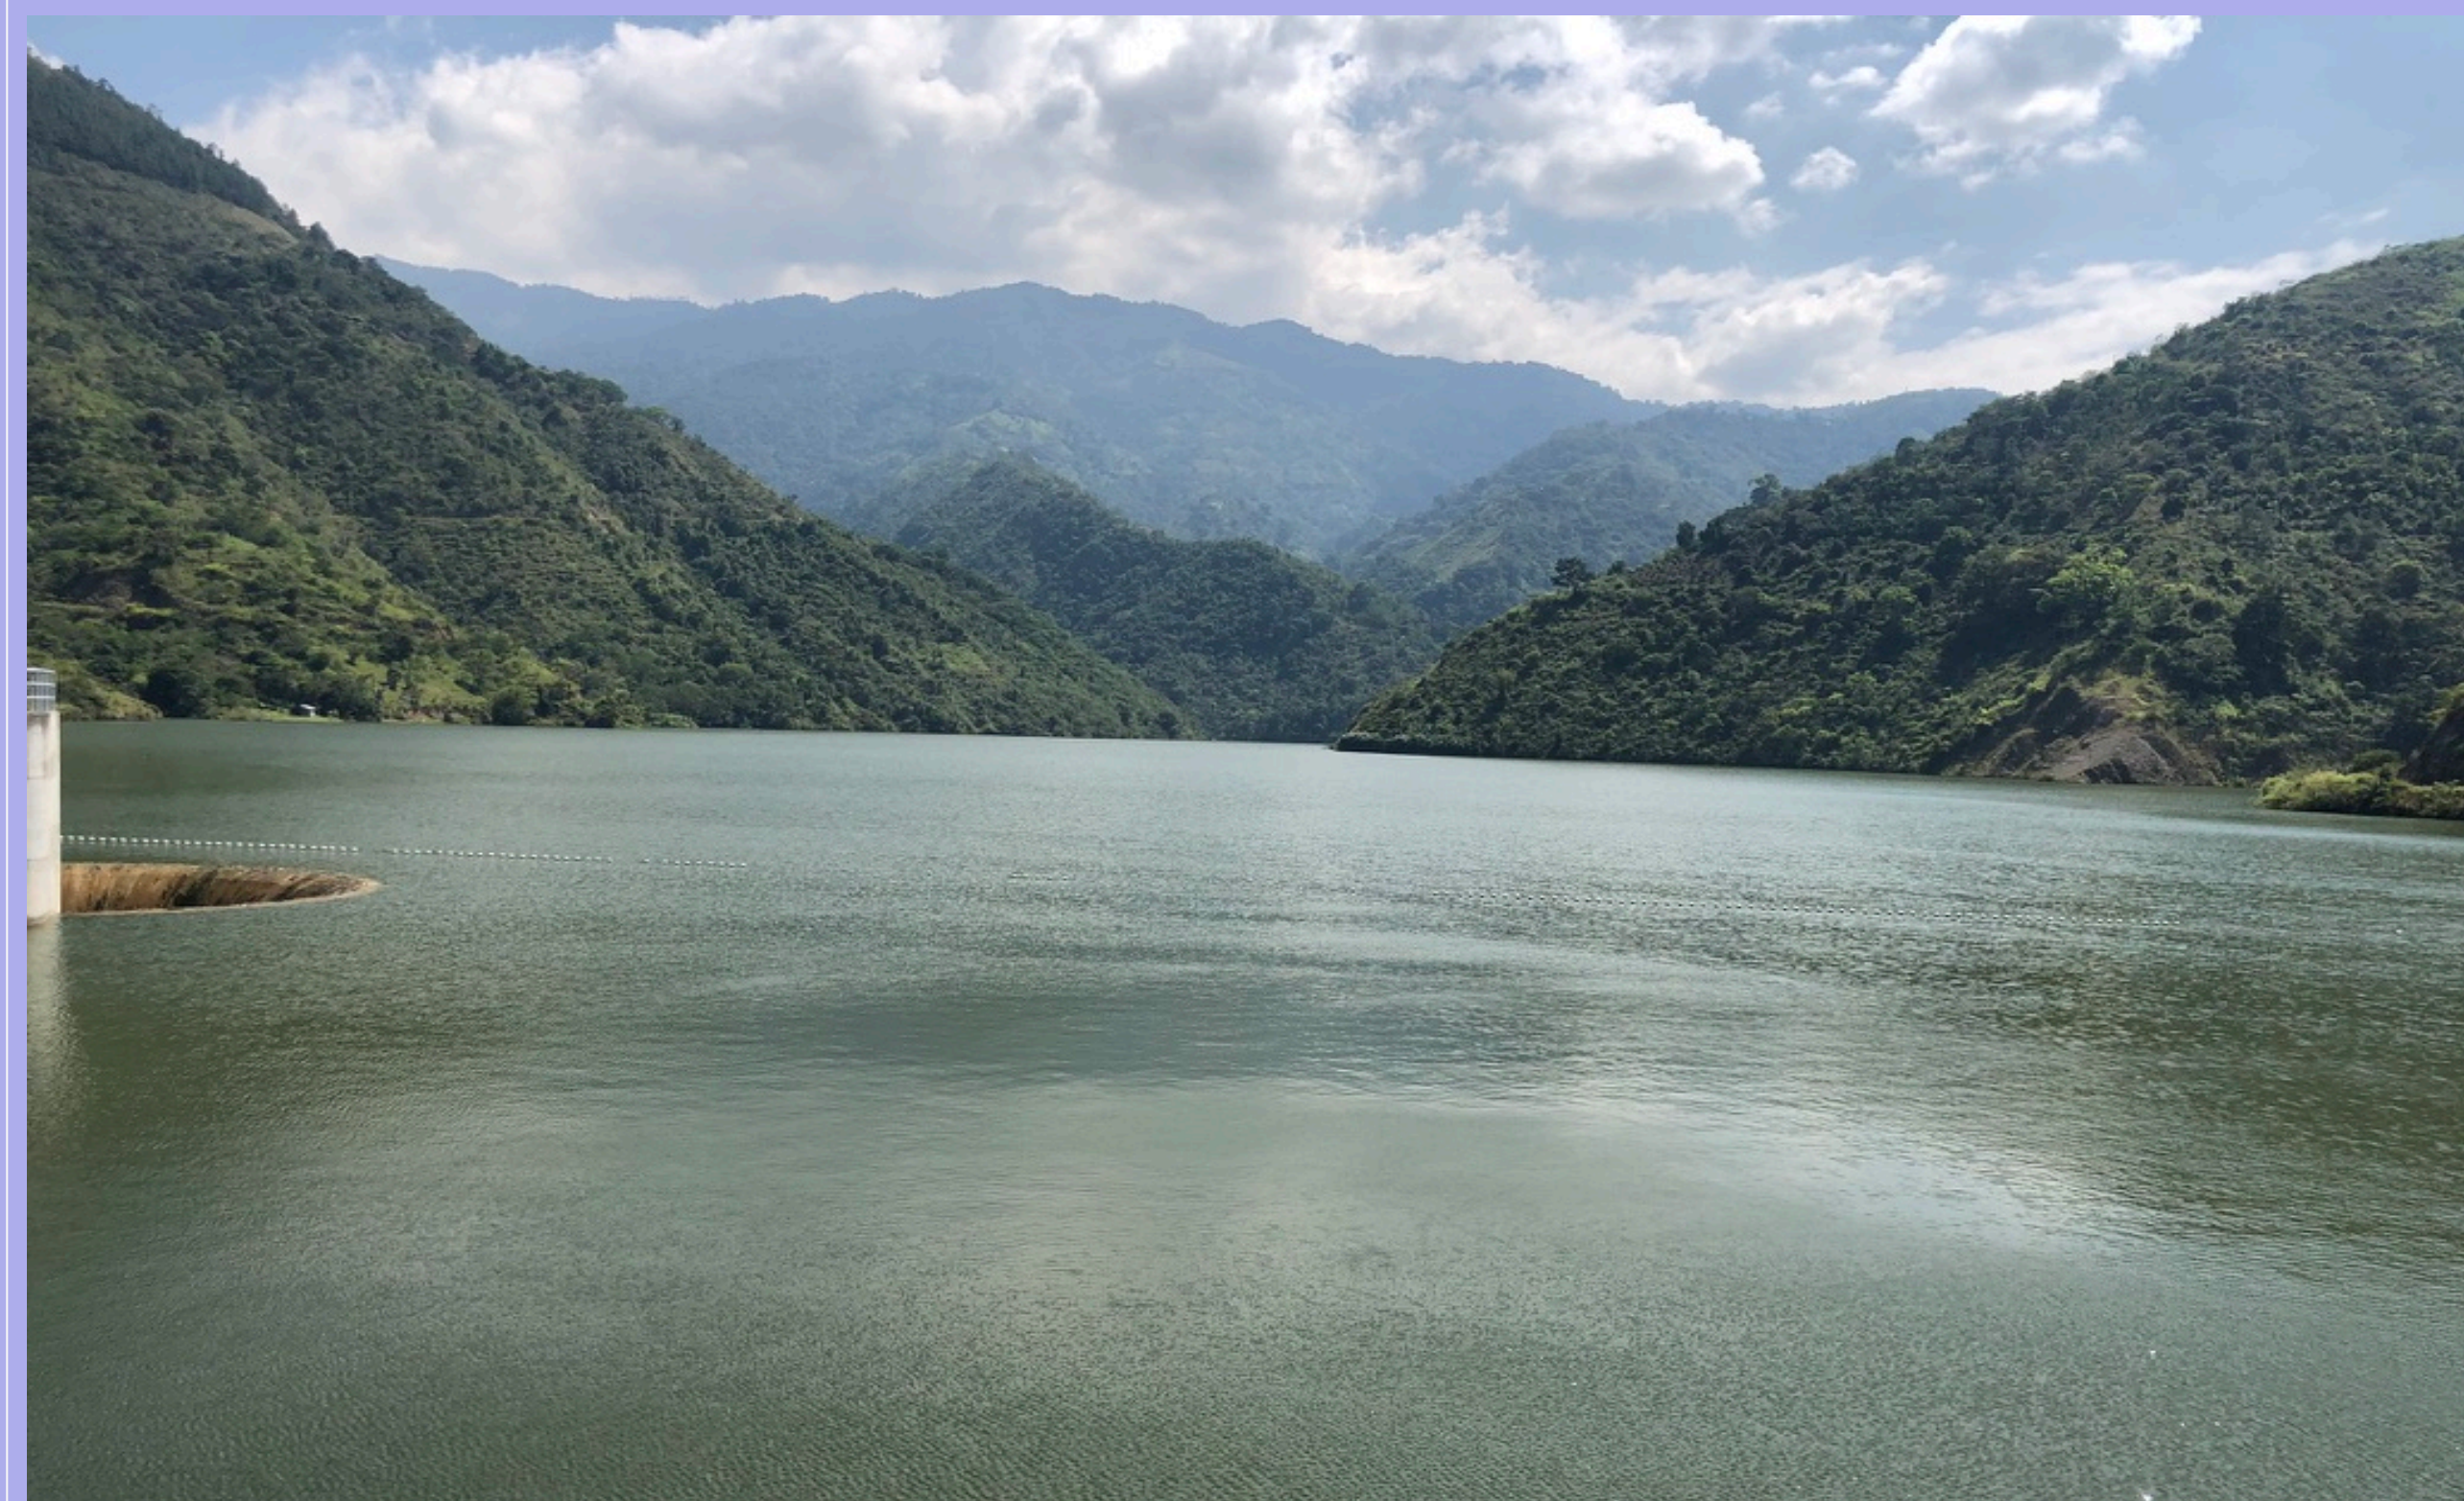
Figure 2. Bosconia reservoir

Bosconia reservoir

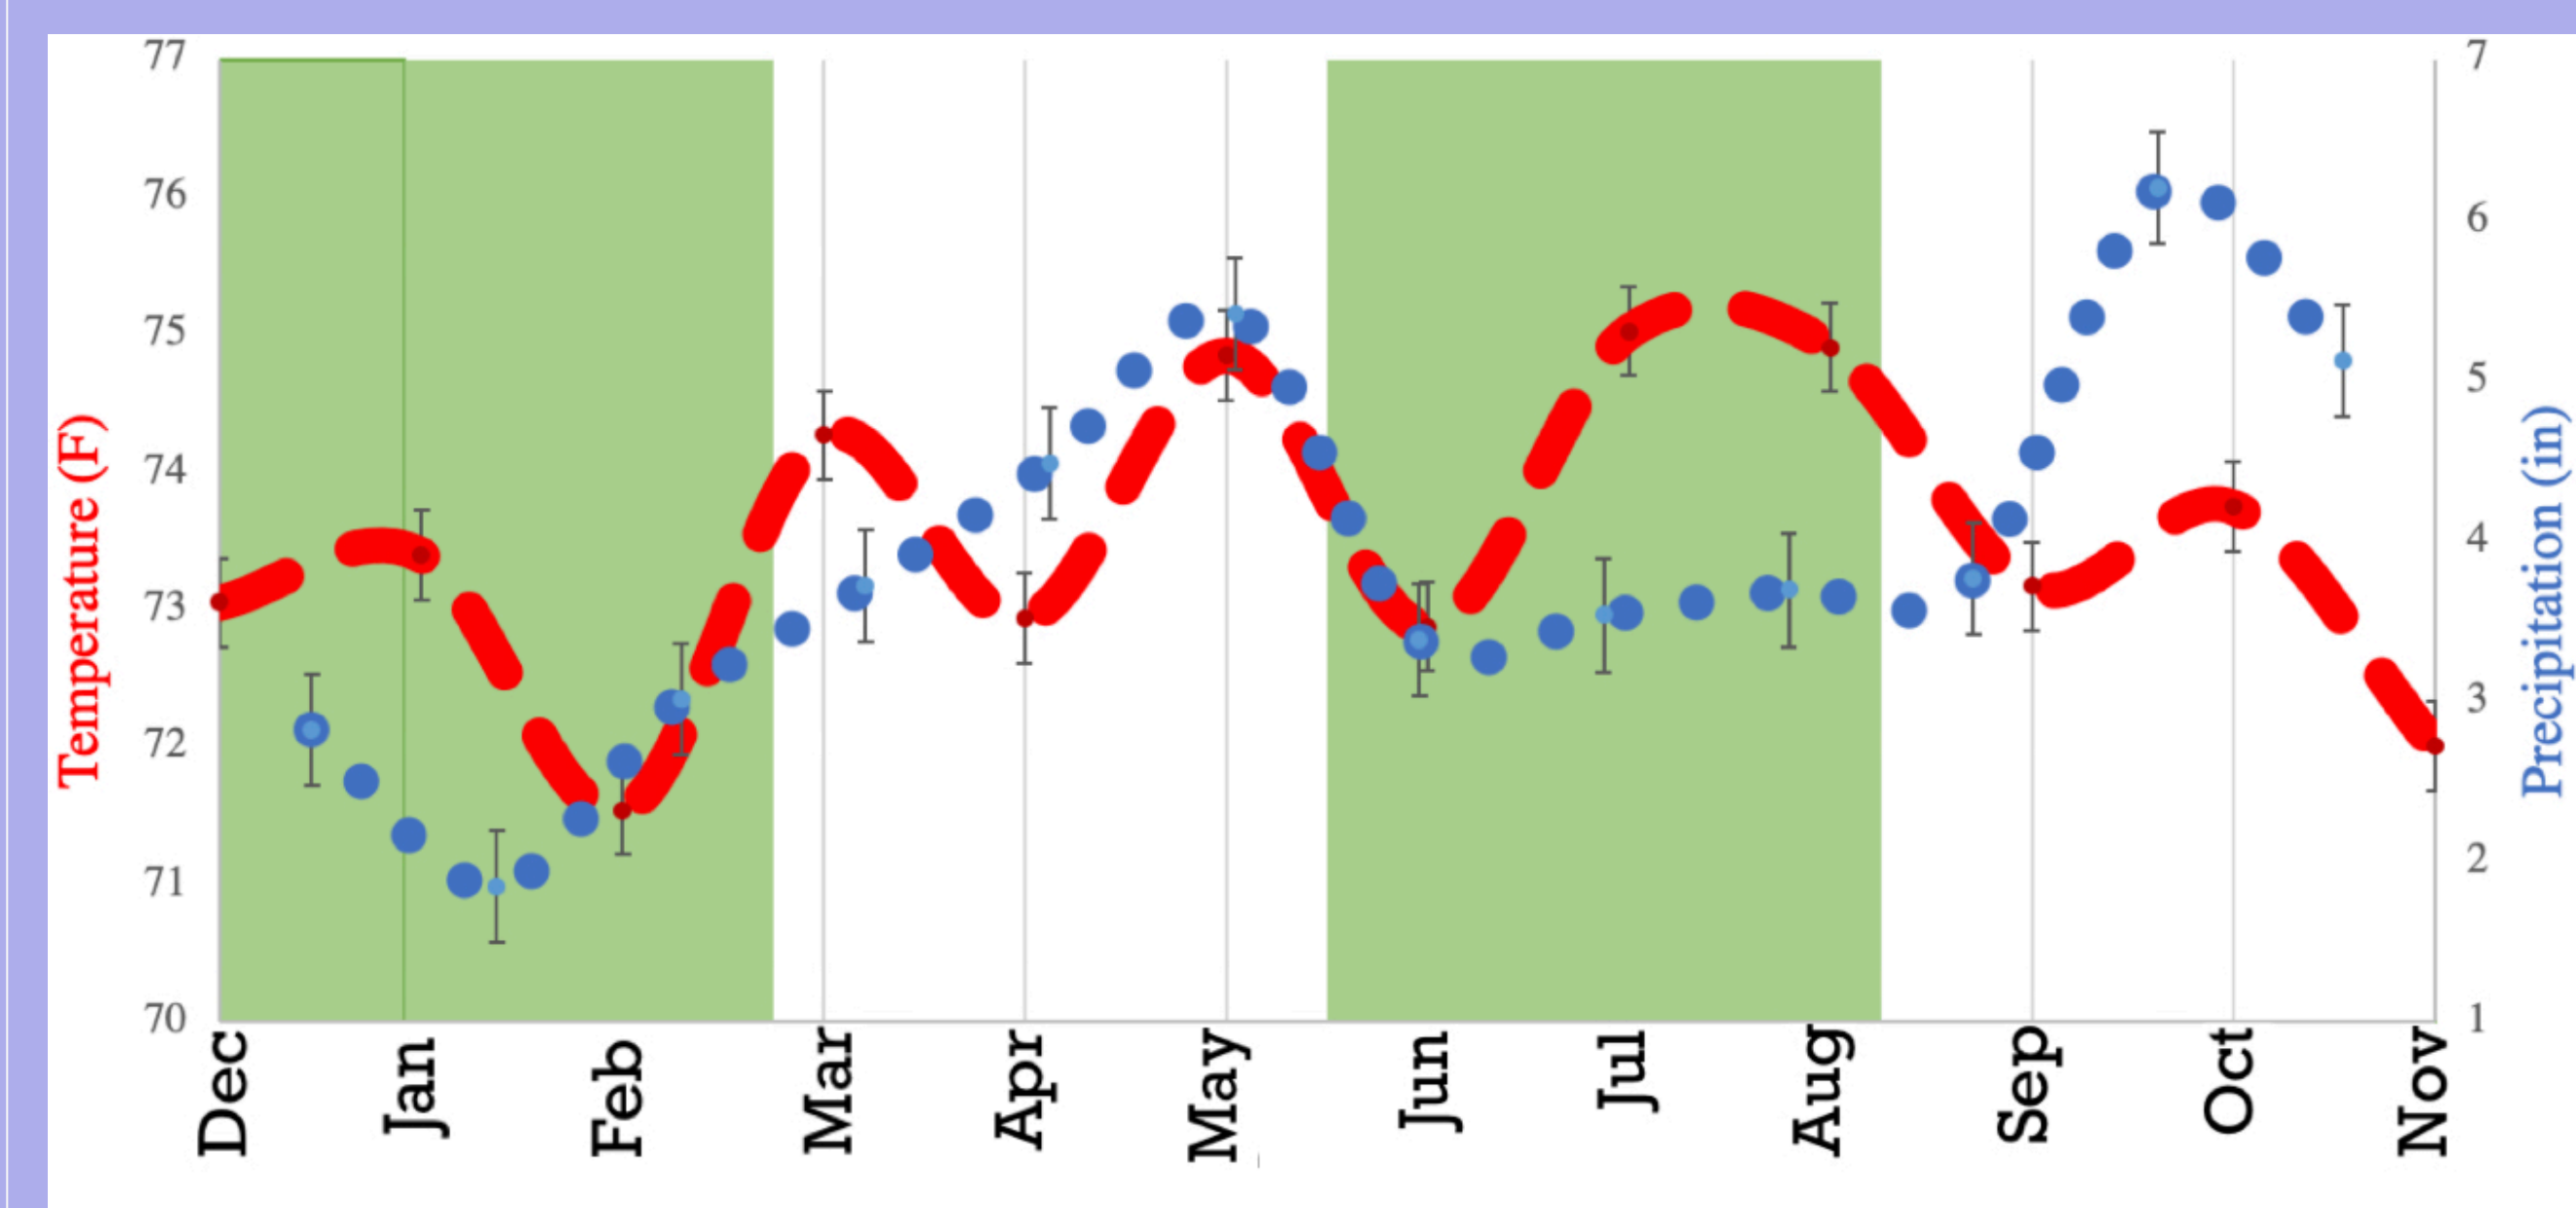
Figure 3. Bucaramanga's weather pattern over a year.

Shown by a defined weather pattern of four seasons, two dry and two wet, Bucaramanga has an average of six dry months. This dry period aligns with consumer complaints of odor and taste changes after 2015.

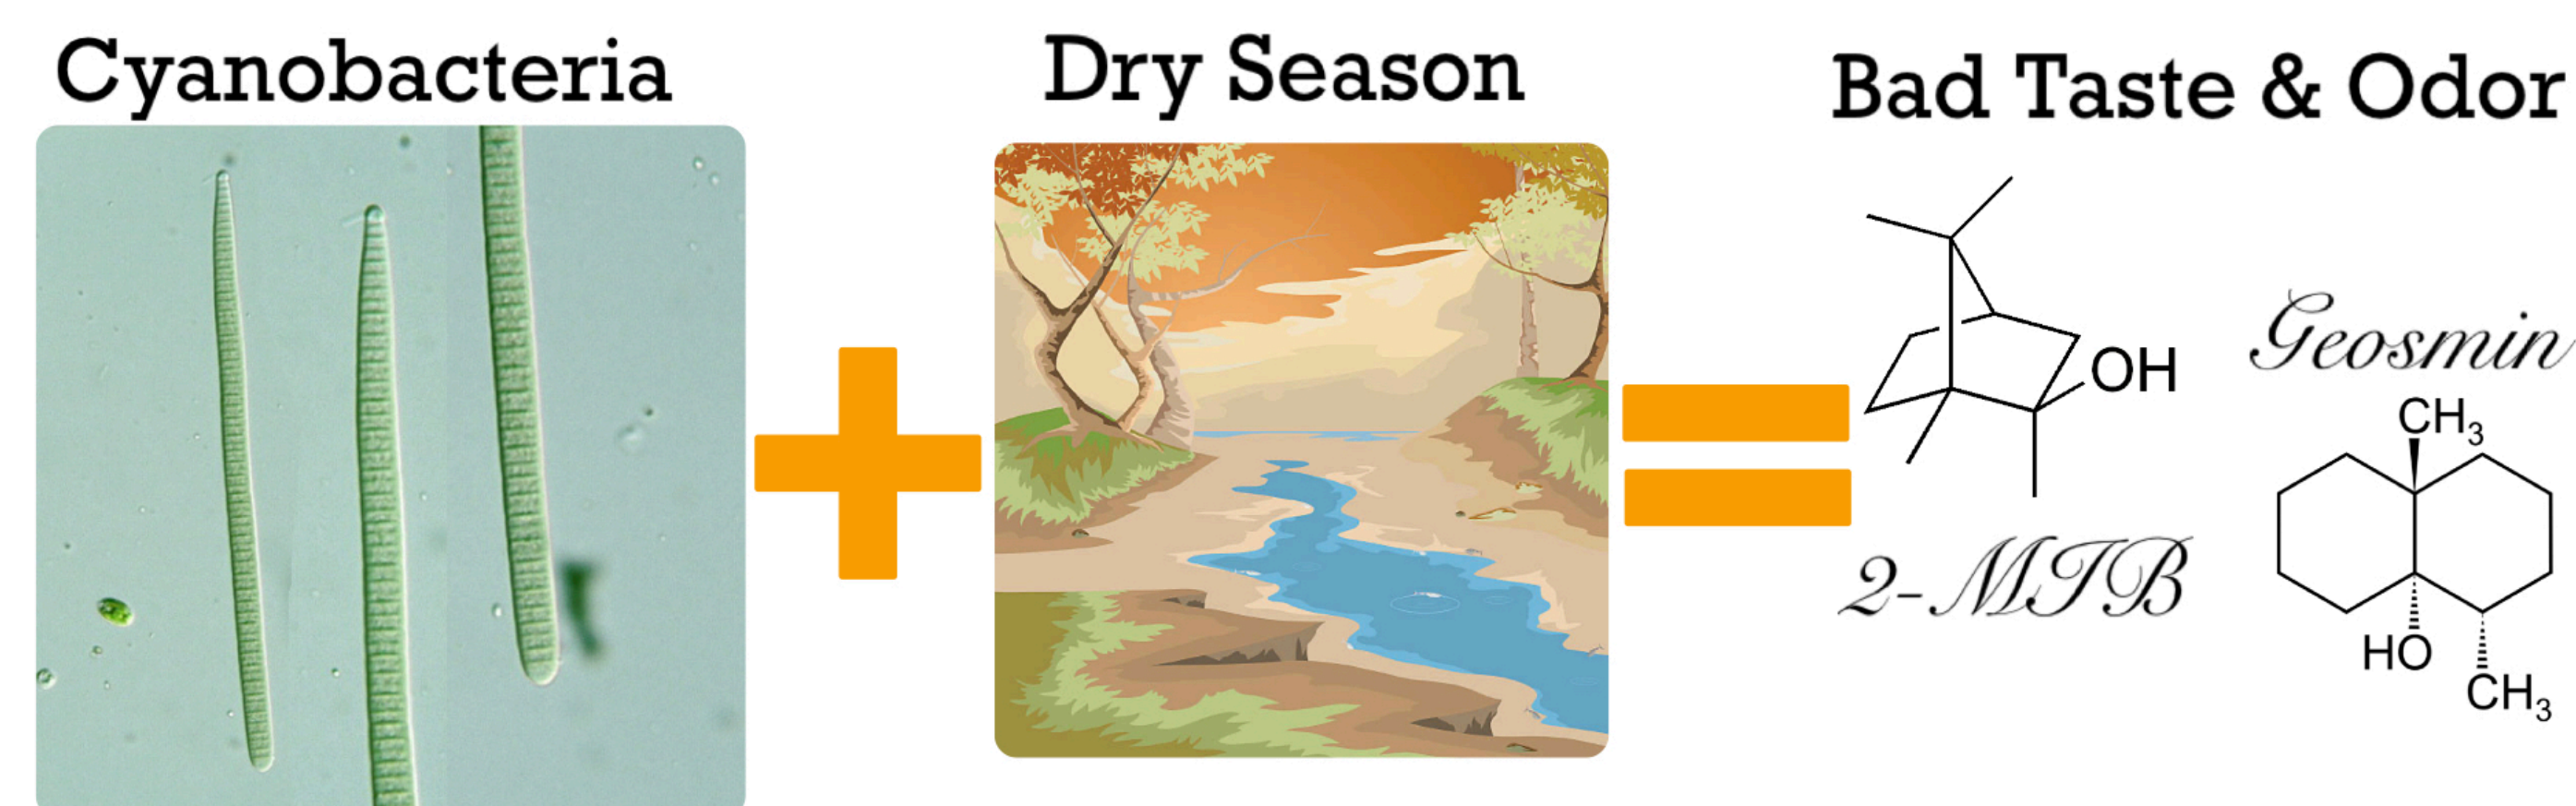
Figure 4. Formation of Geosmin and 2-MIB.

Due to the environmental conditions caused by the dry season, the cyanobacteria are releasing organic compounds such as Geosmin and 2-MIB.
