Massive Ground Control

Failures in Coal Mines

Keith A. Heasley
C. T. Holland Professor
Mining Engineering
West Virginia University

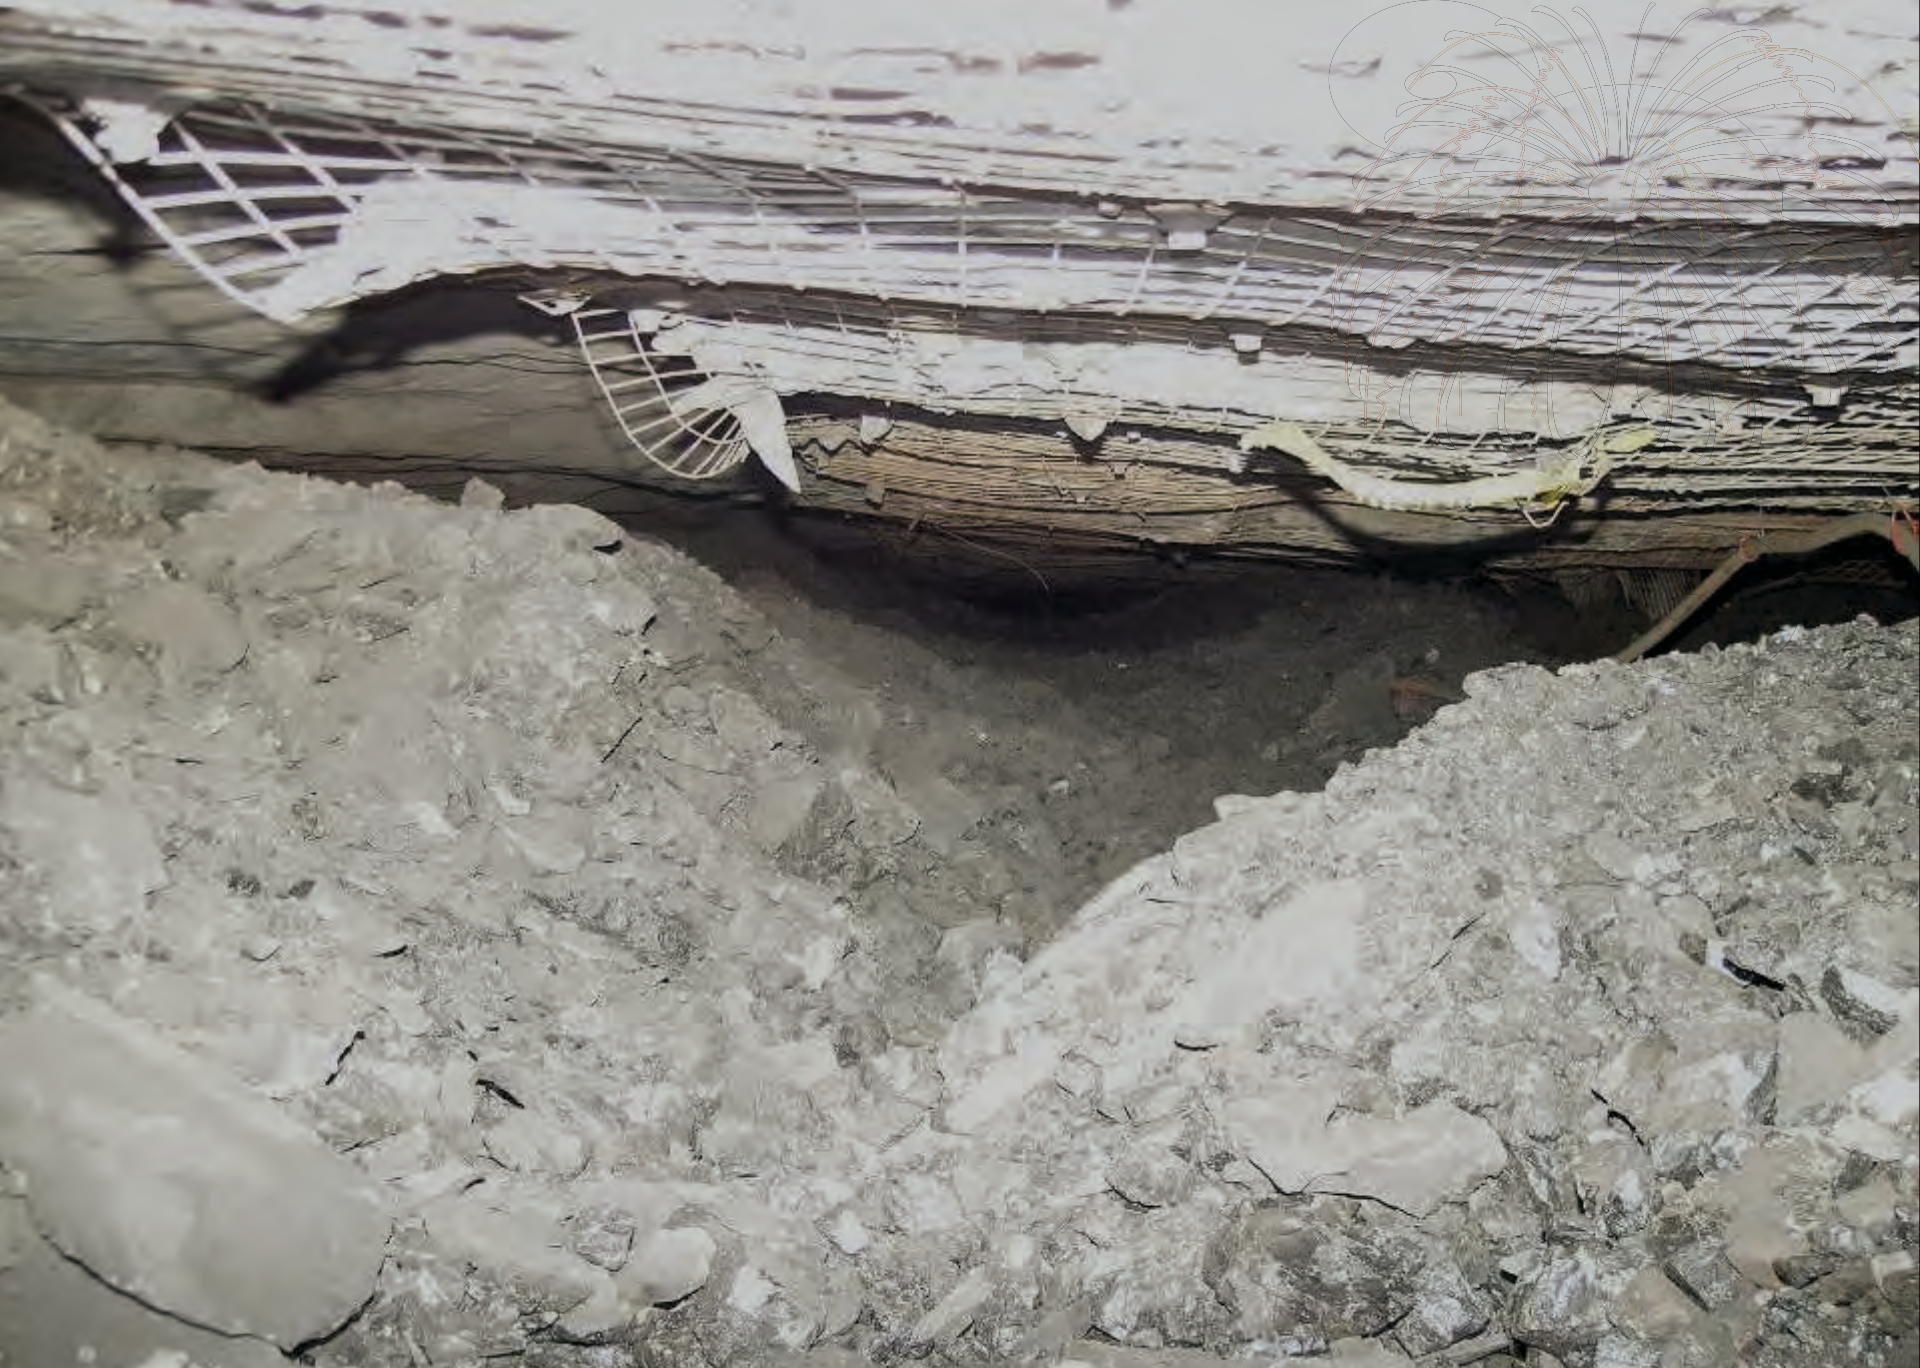
South Barrier 4entry Looking inby CC120 in #3 entry, 8/9/07 – Bump Damage

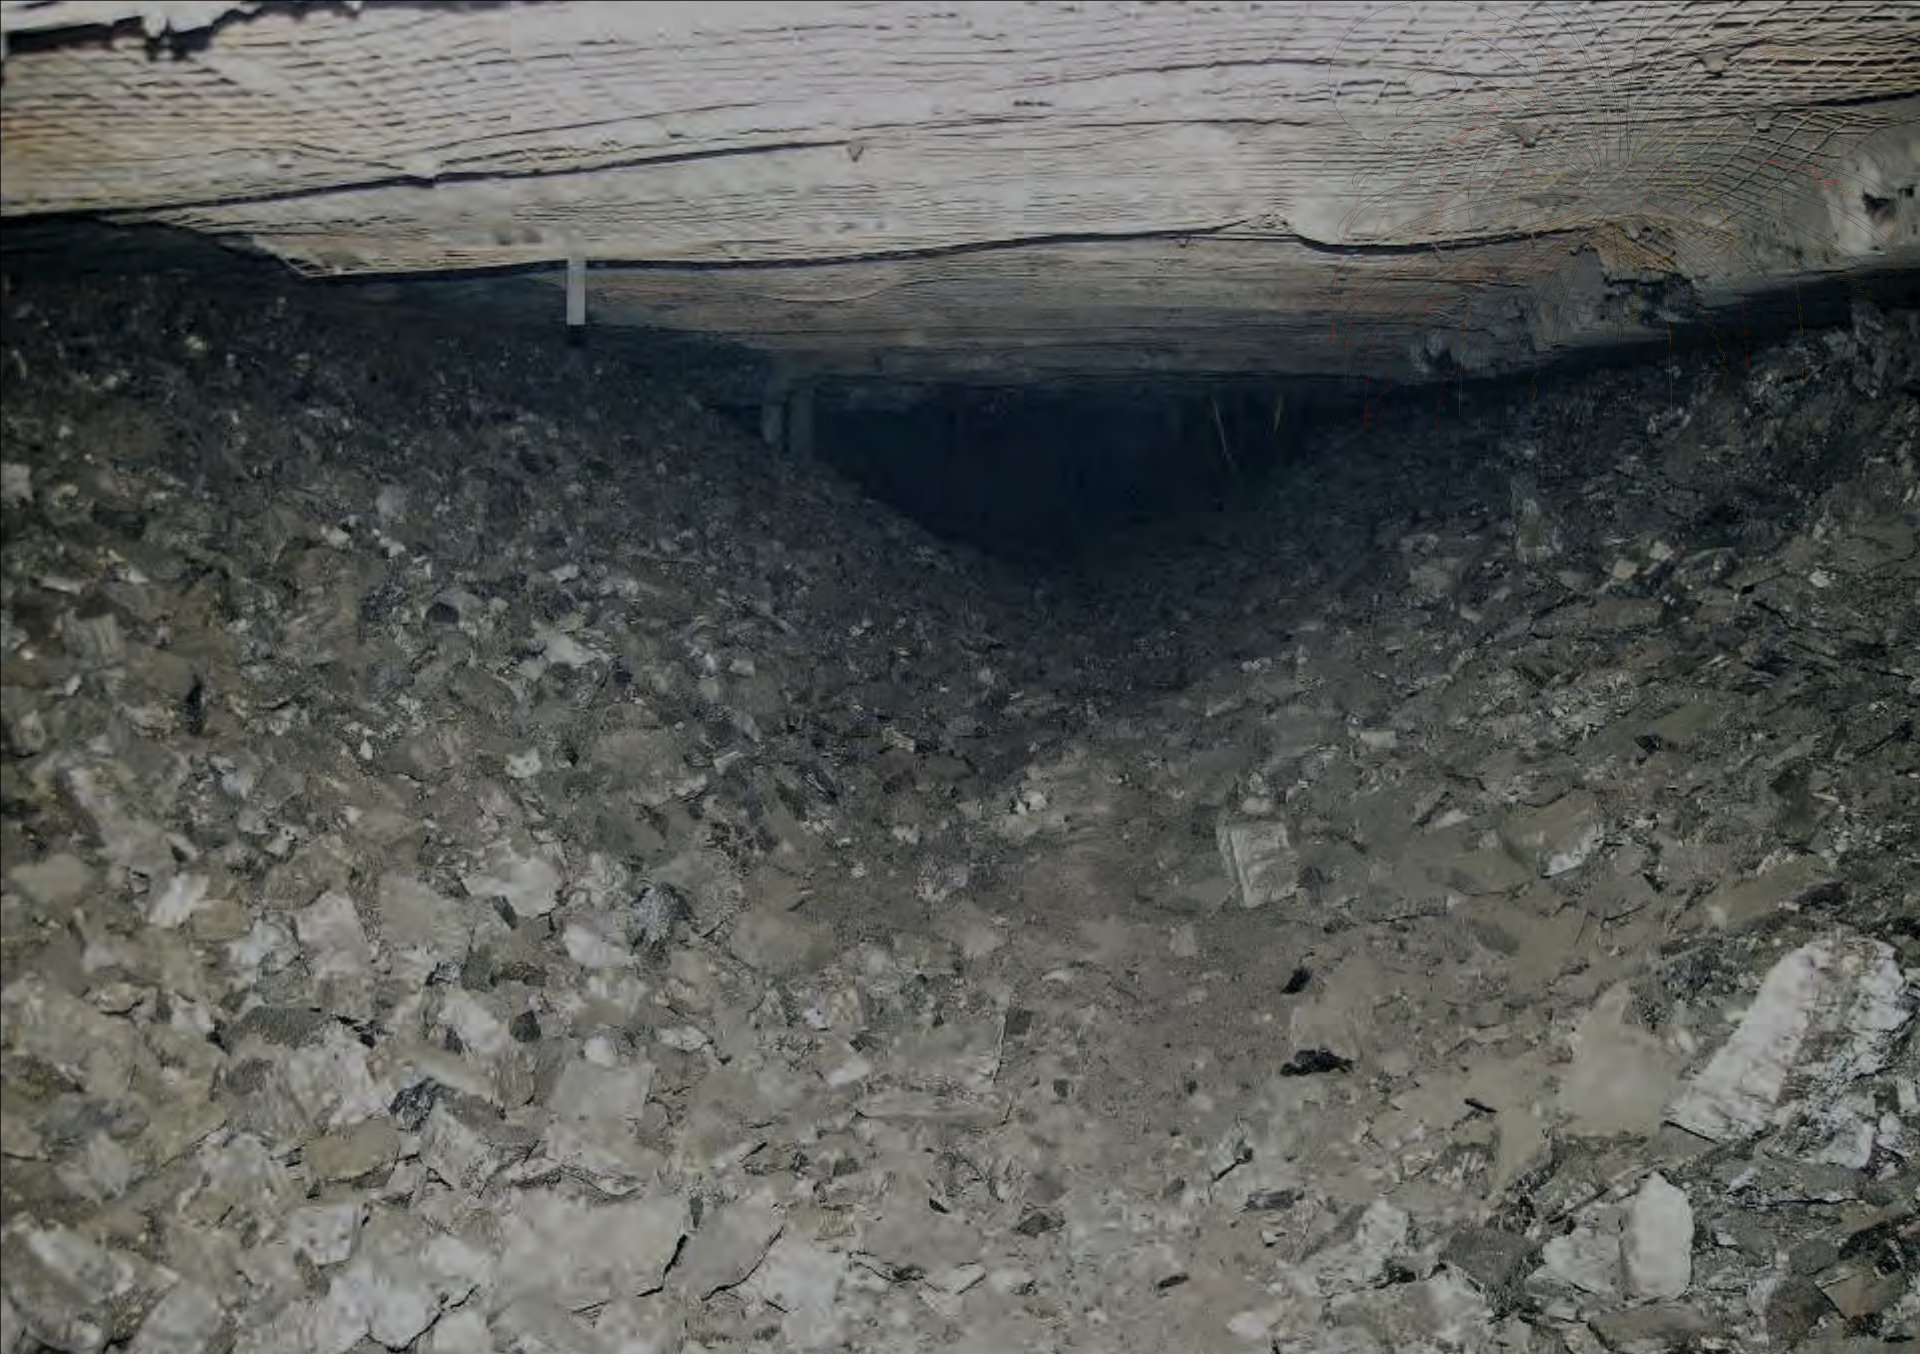
South Barrier 4entry Looking inby CC119 ½ in #4 entry, 8/9/07 –Bump Damage

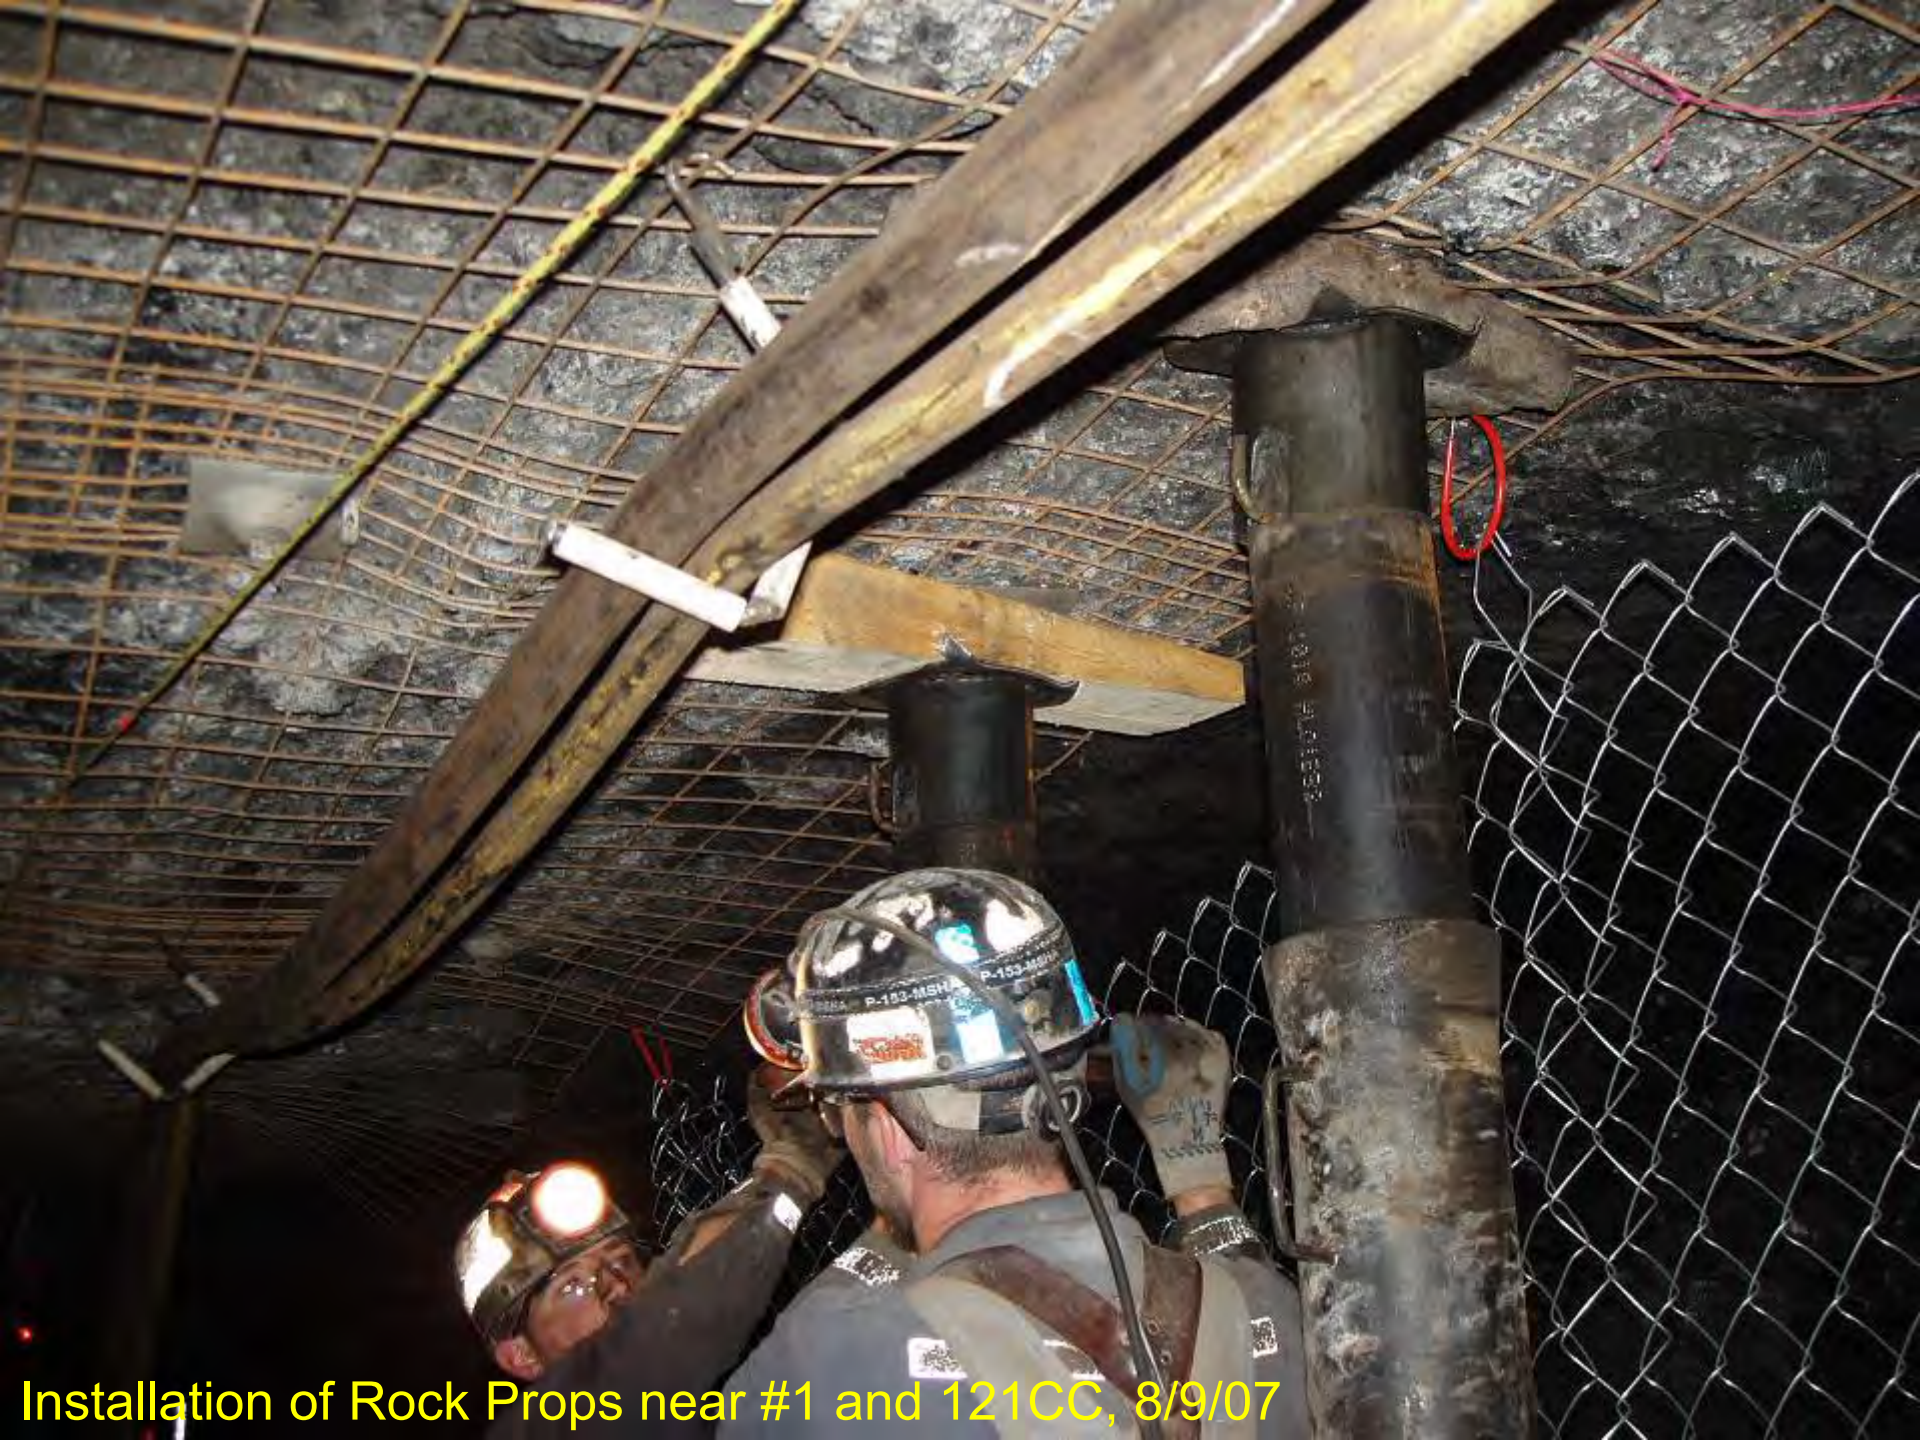
Installation of Rock Props near #1 and 121CC, 8/9/07

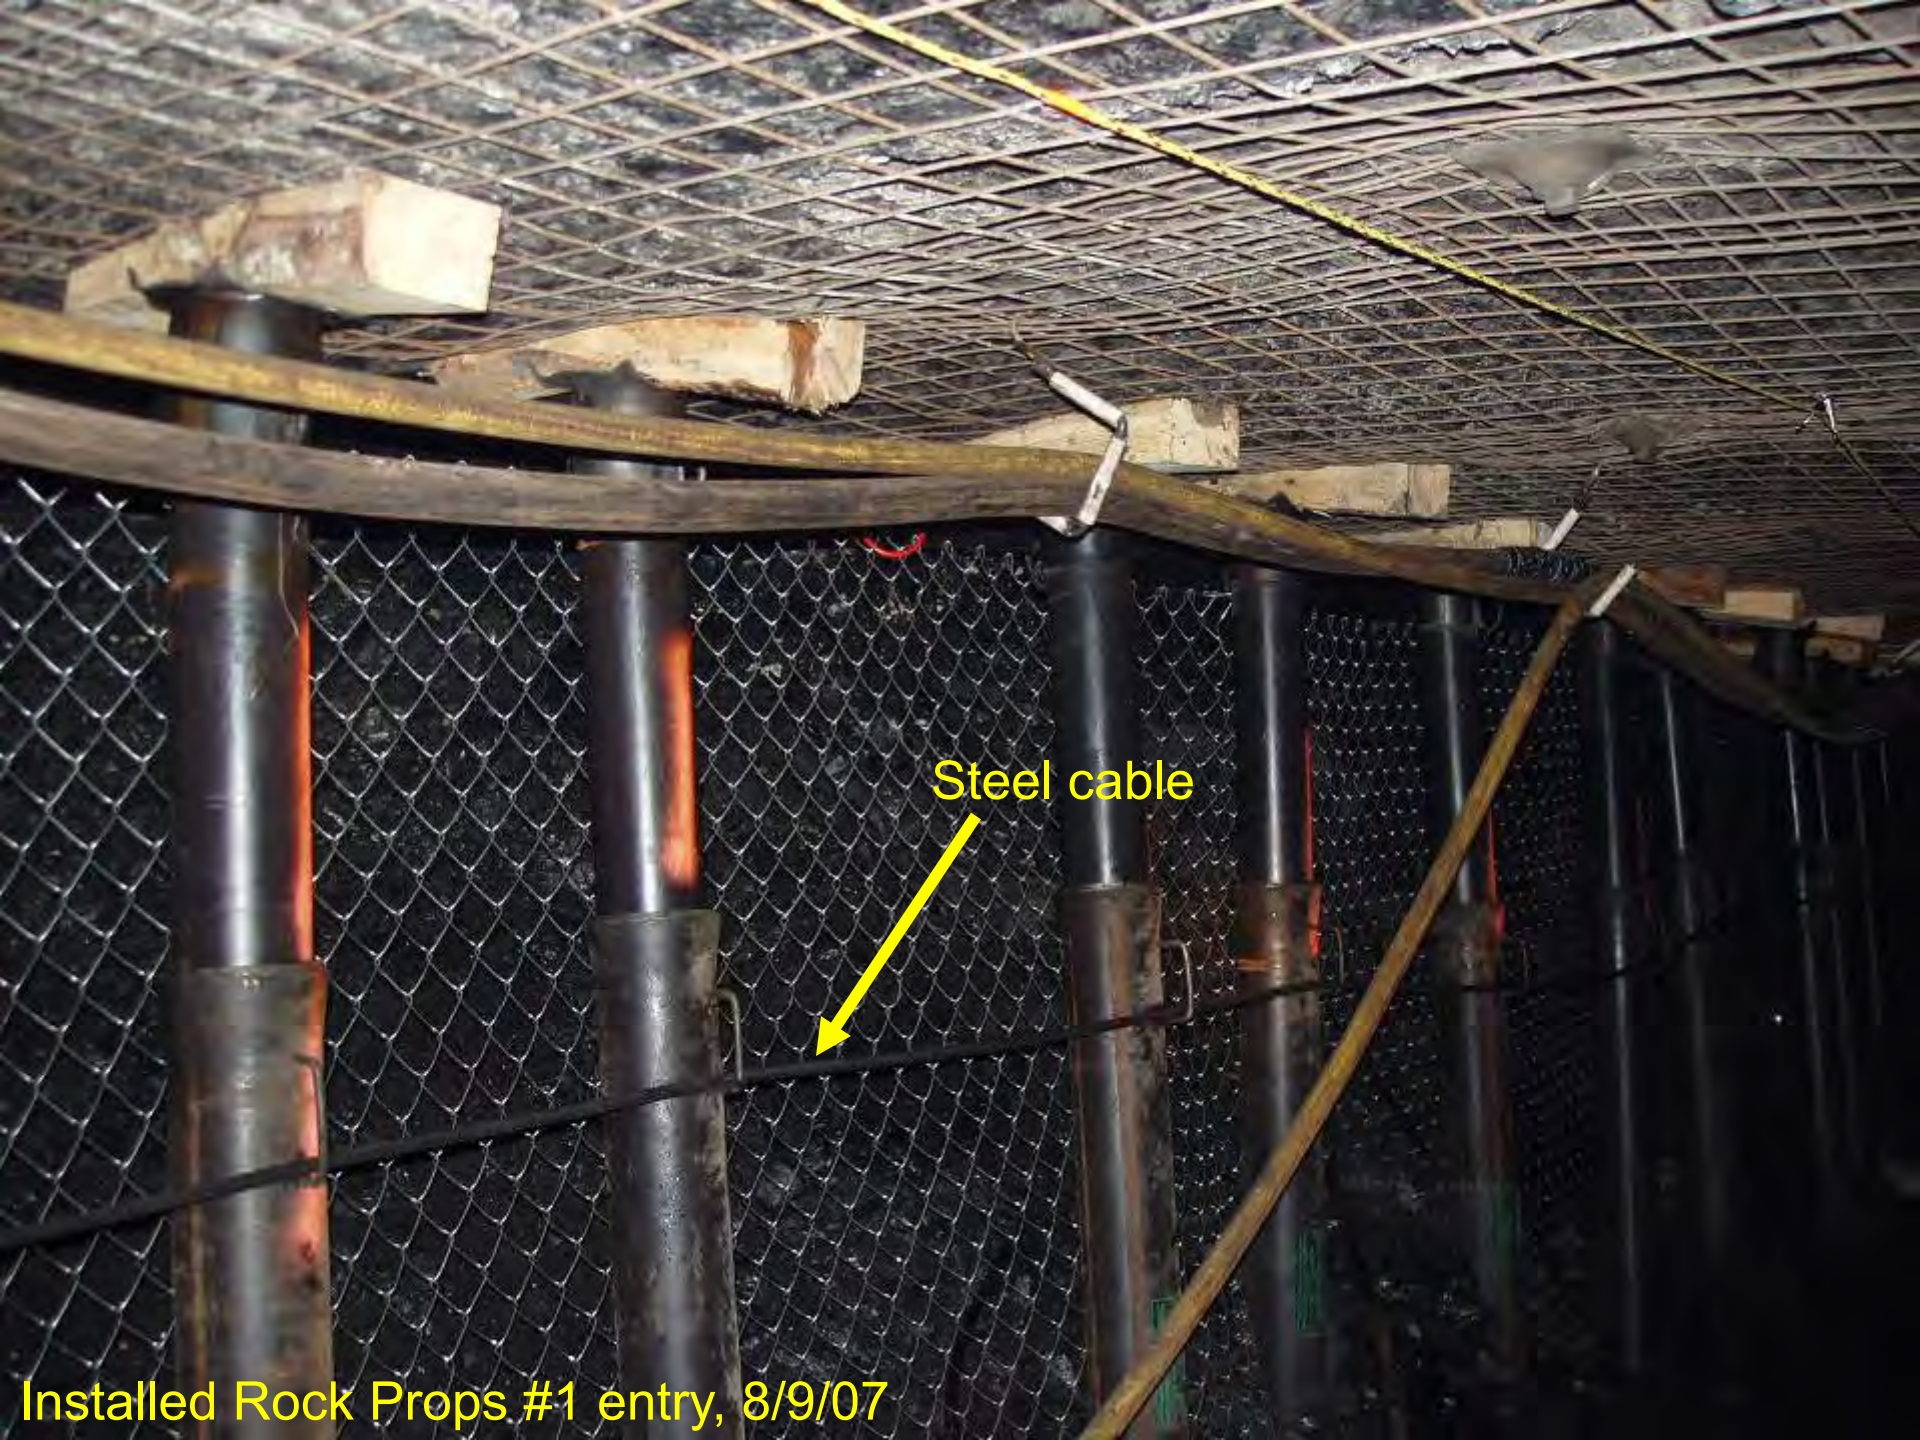
Steel cable

Installed Rock Props #1 entry, 8/9/07

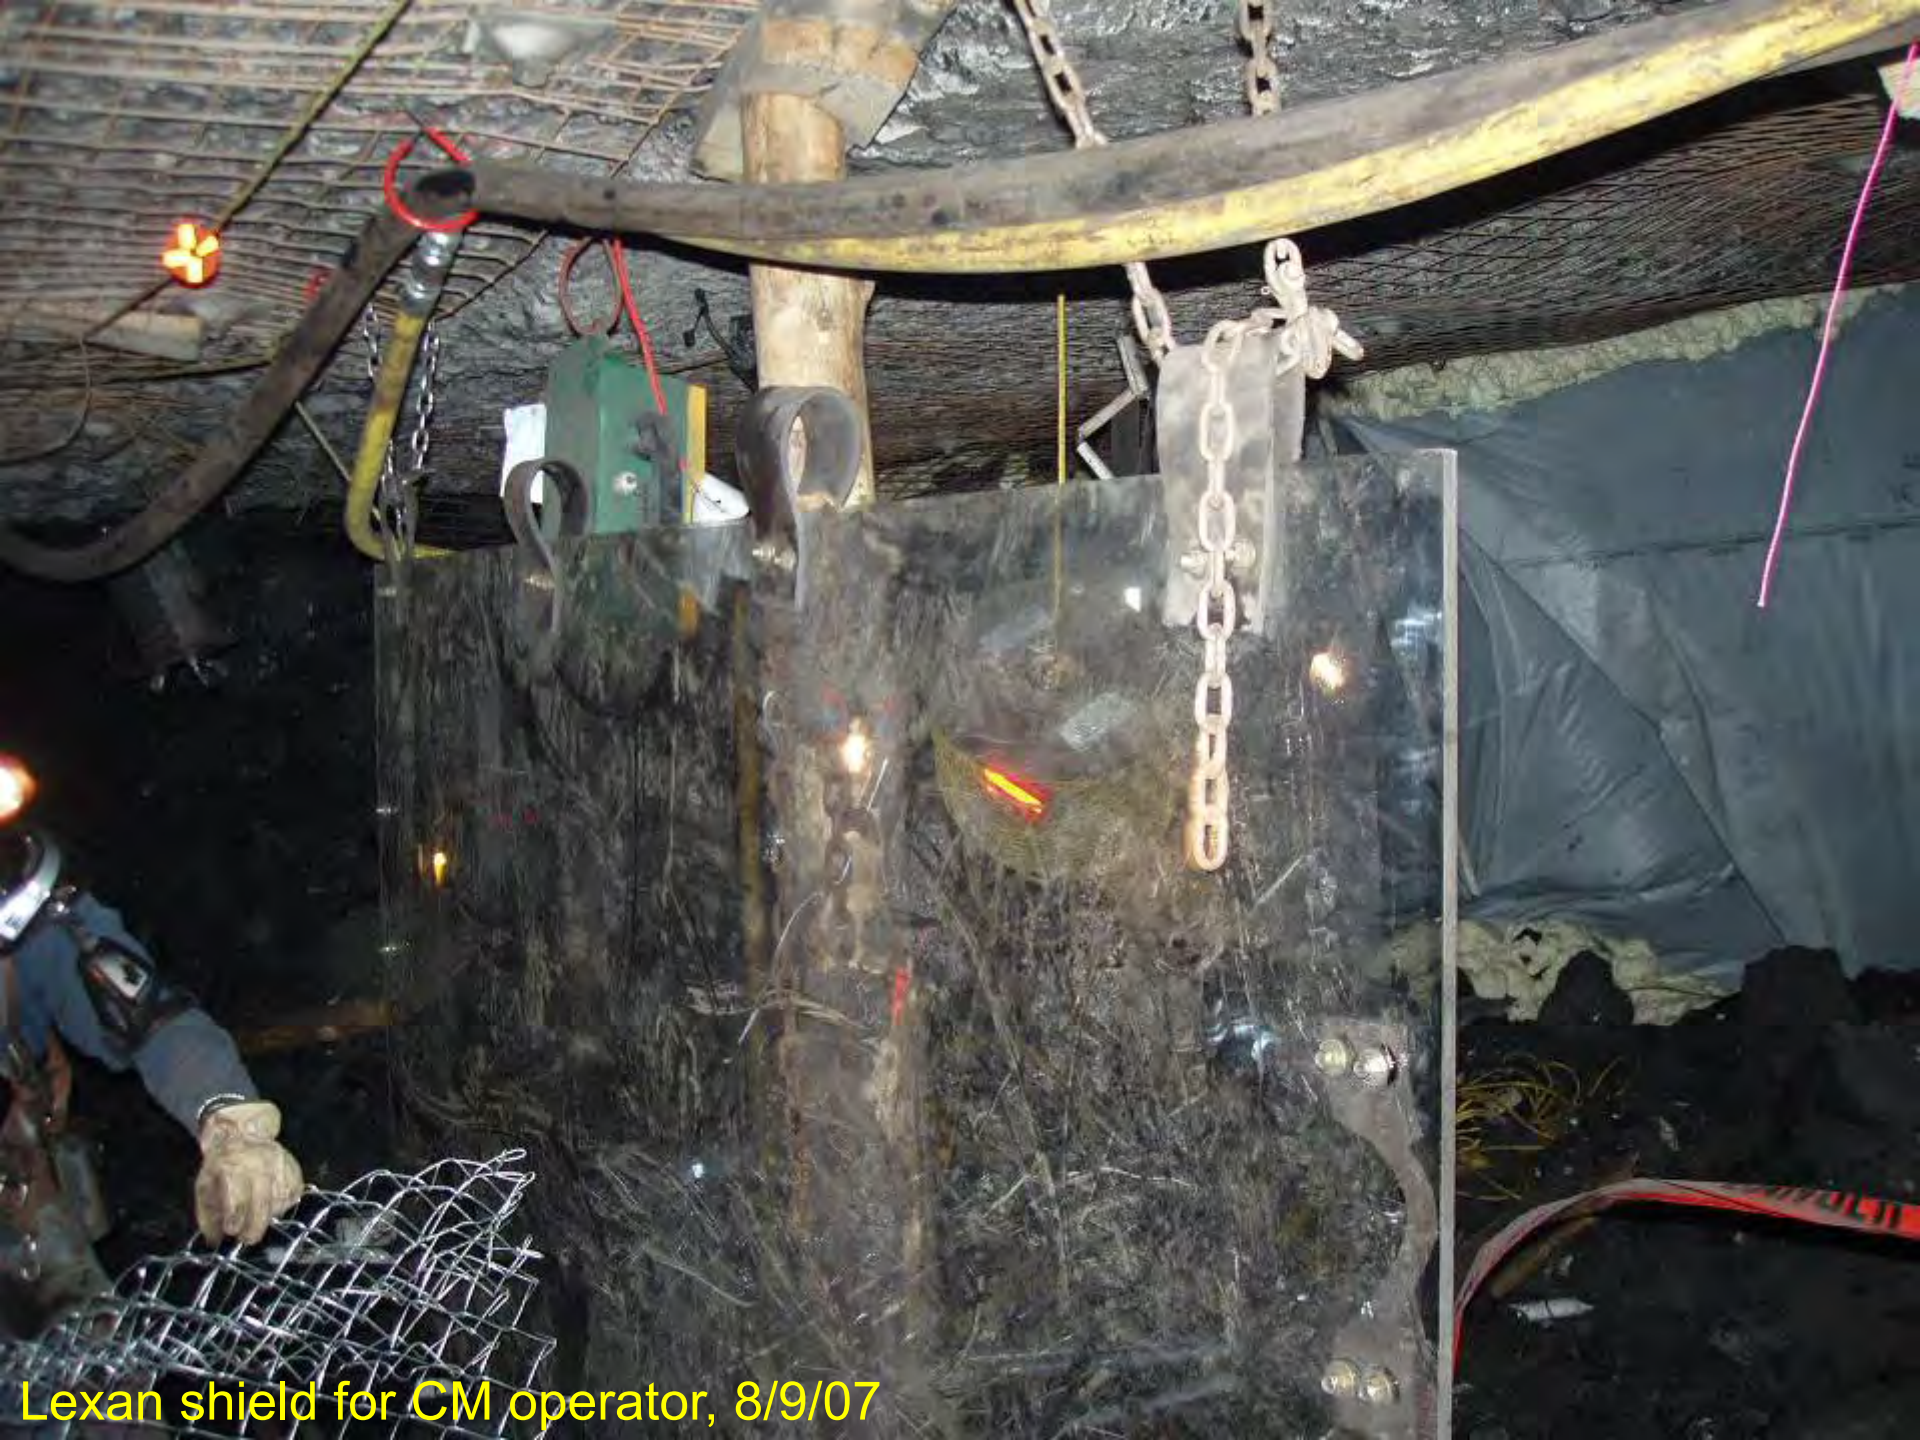
Lexan shield for CM operator, 8/9/07

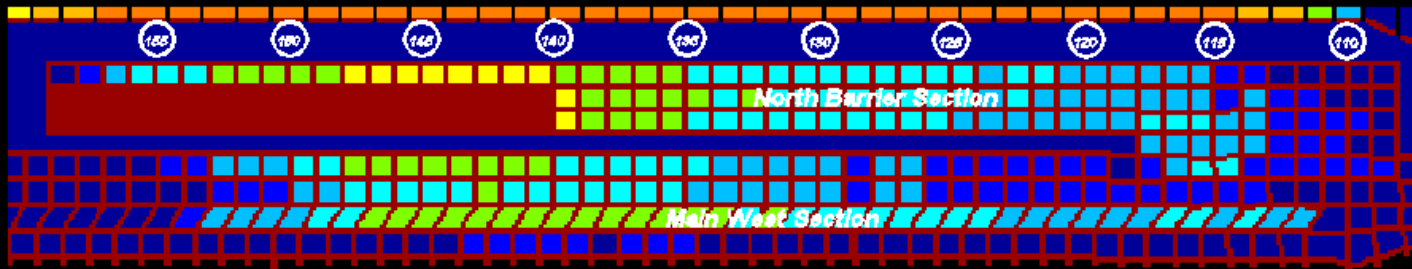
B. Retreat Line at XC 140

Pillar Safety Factor

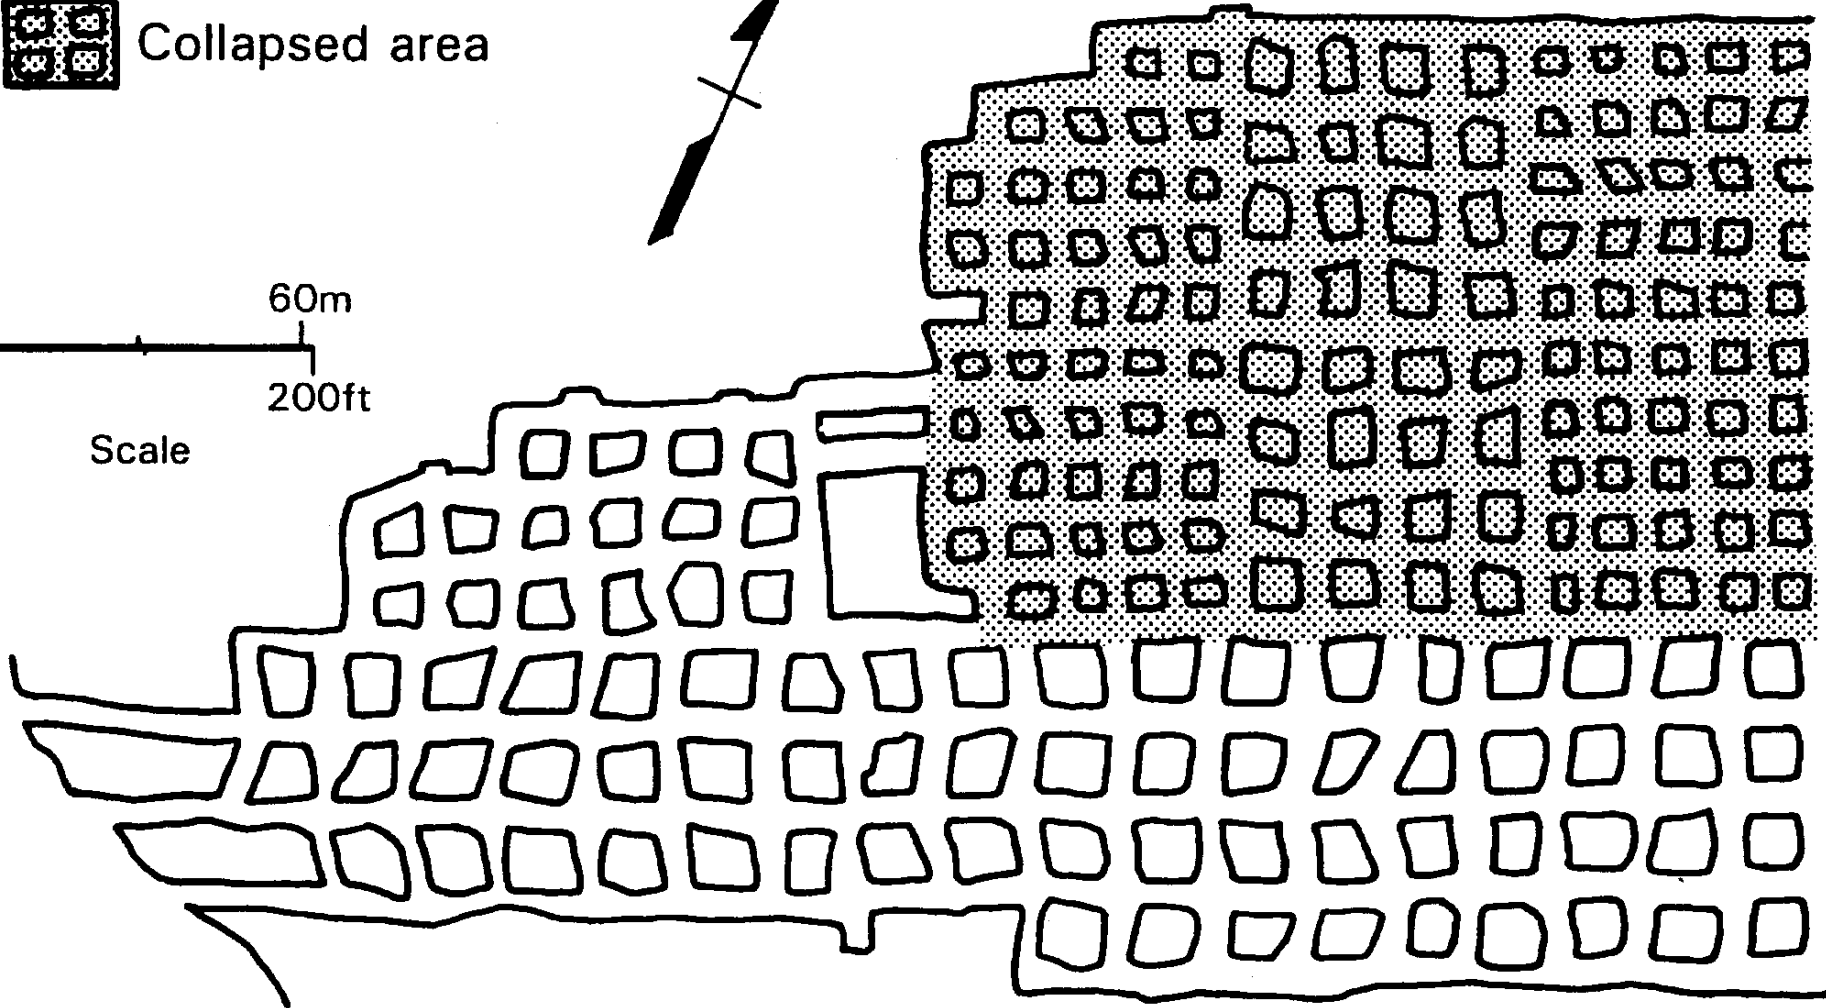
Mine D

Collapsed area

- **Mine D – Mingo County, WV (1992)**
 - **Dorothy Seam – 11.0 ft Thick**
 - **20 X 20 ft Pillars, SF = 1.15**
 - **30 X 30 ft Pillars, SF = 1.45**
 - **225 ft Deep, CMRR = 81**
 - **106 Fenders, 37 Stoppings**
 - **No Fatalities, (Blocks Blown 500 ft)**

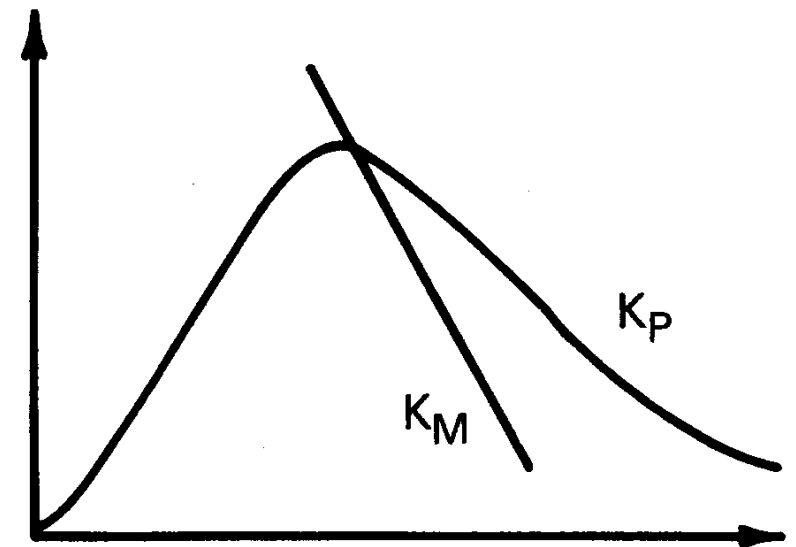
B Stable failure
"stiff" load system

- **Slender pillars shed load**
 - **Slender pillars have steep post-failure modulus**
 - **Local Mine Stiffness criteria is violated**
-
