Emergency Shelters

SEEK REFUGE
*Your Third Line
of Defense*

**A Technology Transfer Seminar
Greensburg, PA
MAY 27, 2010**

W. Va. Office of Miners' Health Safety and Training
May 27, 2010

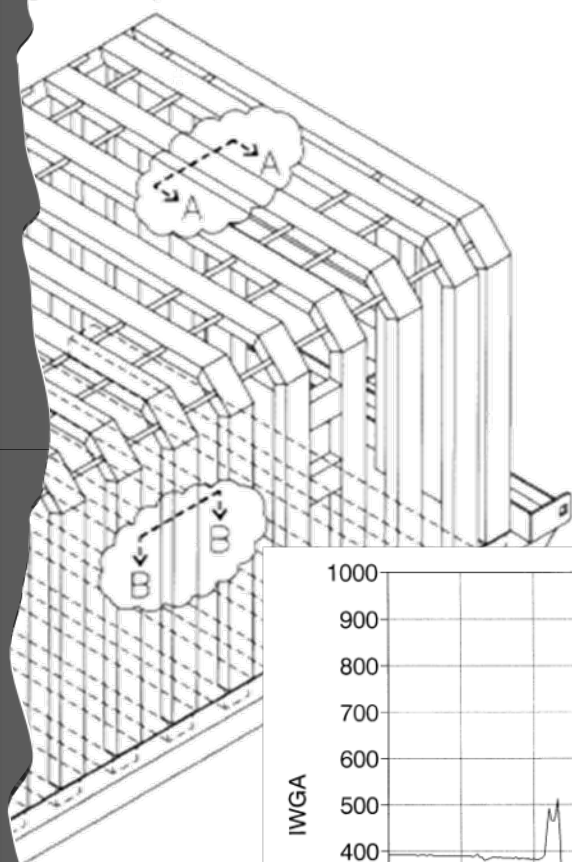
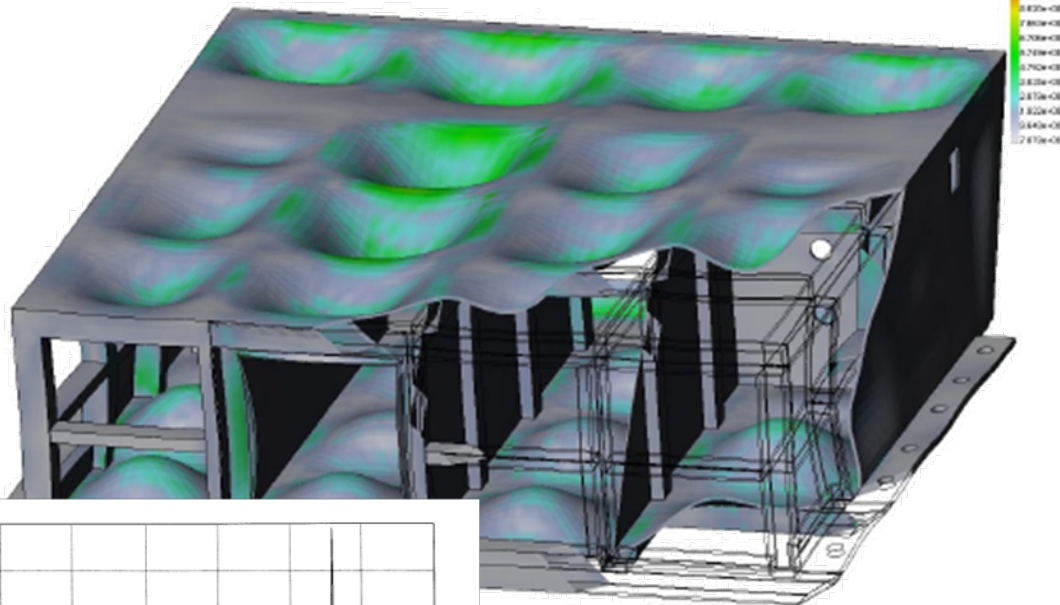
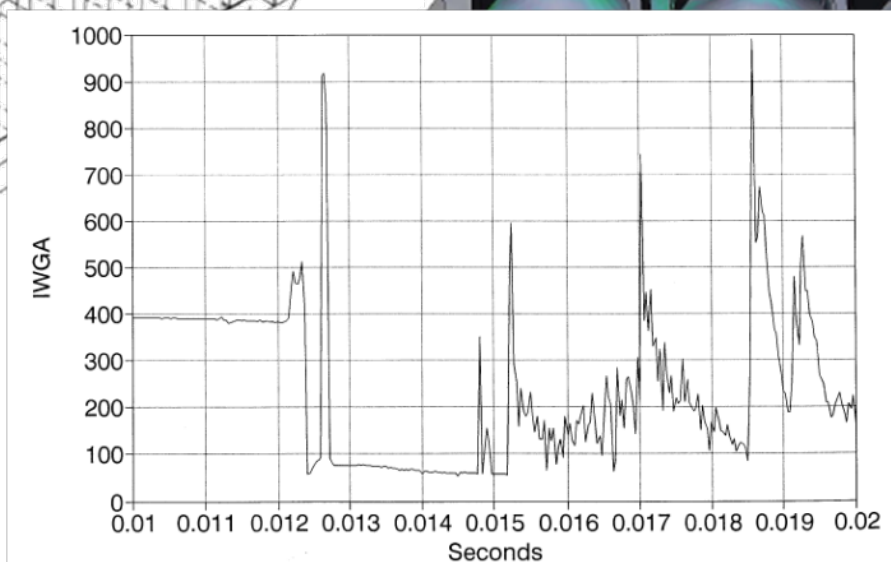
Structural Requirements

Overpressure Pressure: Static Solid Stress
15000 psi Deformation Scale: 200.000

15 psi with 10x exaggeration of deformation

15 PSI Overpressure

300°F Flash Fire

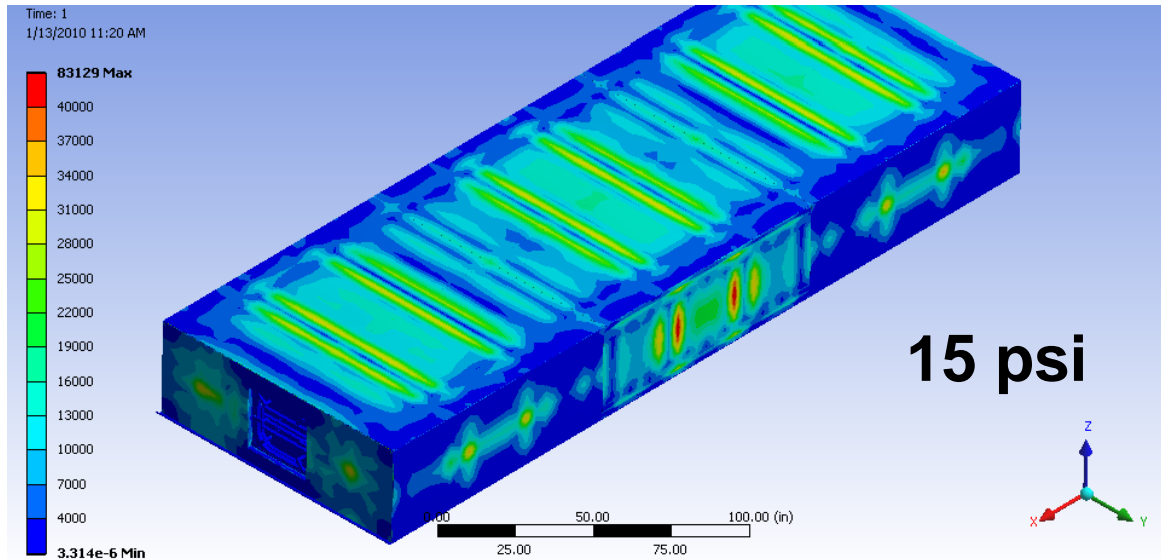
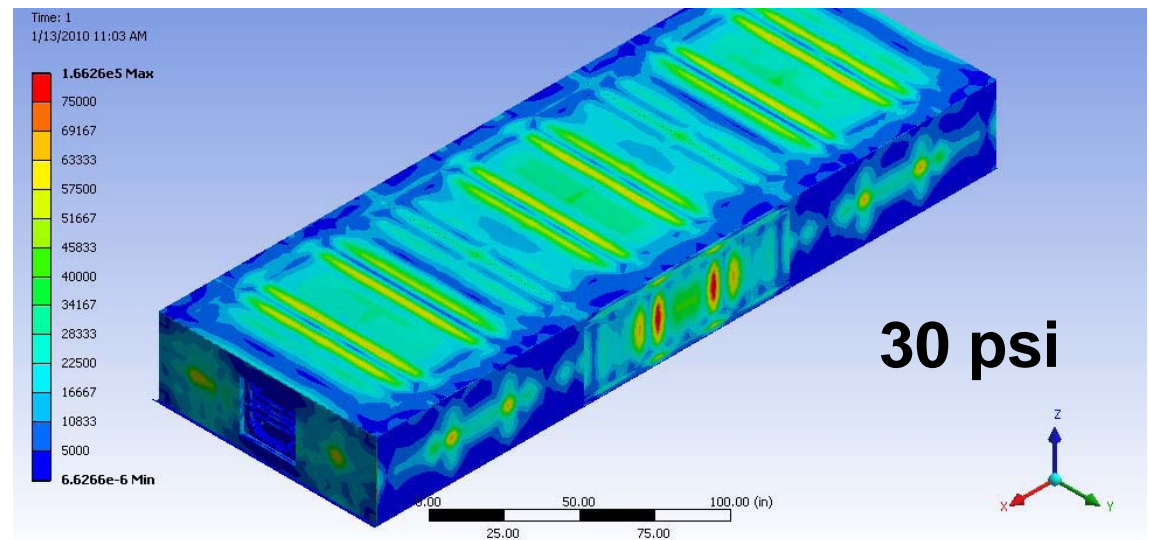
Structural Testing

**Computational
Finite Element
Modeling
Required**

**Results have
been validated by
subsequent
physical testing**

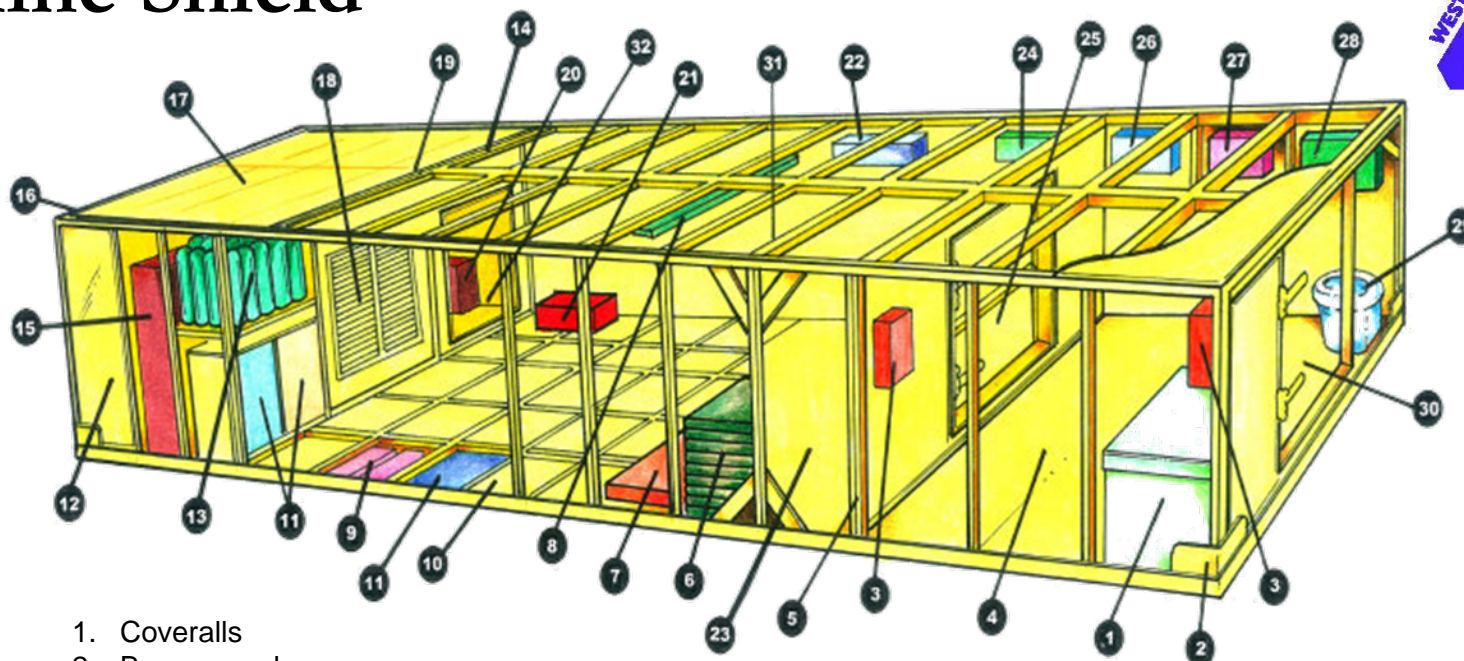
Mine Shield™

| 1. Coveralls | 17. Modular Construction | 31. Sliding Tray With Mounts |
| 2. Bumper pads | 18. Circulating System | 32. Gas Monitoring System |
| 3. Communication System | 19. Battery Packs | 33. Additional Storage |
| 4. Airlock Chamber | 20. 20. Repair Kit | 34. Outside Gas Sensor |
| 5. Reinforced Steel Construction | 21. 21 First Aid Equipment | 35. Air Tight Door |
| 6. Padded Cushion | 22. Gas Monitoring System | 36. Air Purge |
| 7. Additional Soda Lime Cartridges | 23. Additional Storage | 37. Gas Monitor |
| 8. Led Lights | 24. Outside Gas Sensor | 38. Purge System |
| 9. I pod, games, etc | 25. Air Tight Door | 39. Chemical Toilet |
| 10. Fitted panels | 26. Air Purge | 40. Air Tight Doors |
| 11. Food Storage | 27. Gas Monitor | 41. Sliding Tray With Mounts |
| 12. Powder coated panels inside and out | 28. Purge System | |
| 13. Tanks | 29. Chemical Toilet | |
| 14. Reinforced Roll Cage | 30. Air Tight Doors | |
| 15. Compressed Air / Manifold System | | |
| 16. Maintenance Door | | |

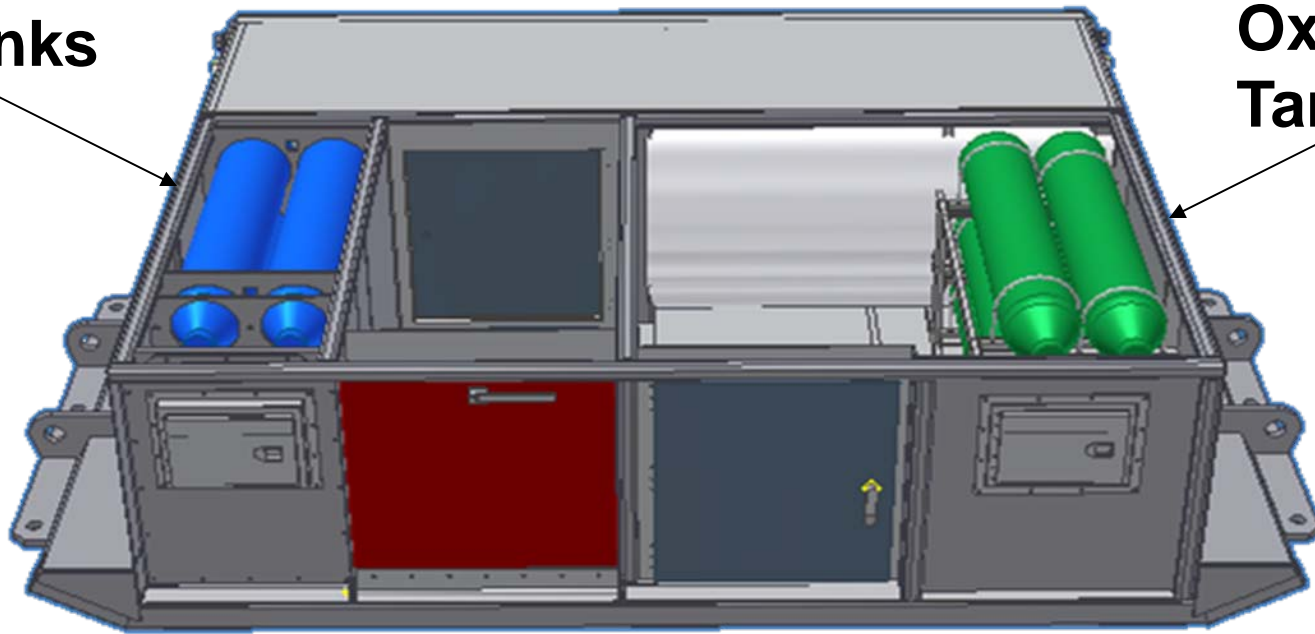
Packed Shelter

Air Tanks

Oxygen
Tanks

Oxygen, Food, Water & Additional Supplies

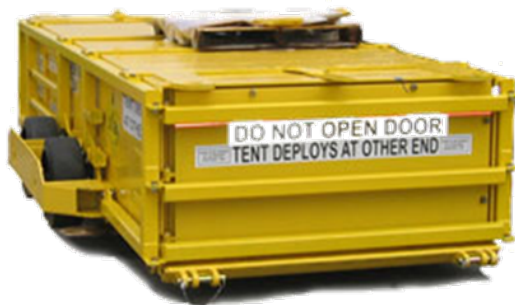
Fresh Air Bay that were further away had apparent shrapnel (like hail storm) damage and some showed signs of heat buckling but no viable heat damage to paint.

It appears the units behaved as expected. The ones where survivors might have reached survived and the one where they could not have survived suffered their fate.
