LionTech Rocket Labs

2017-2018 USLI Project Nimbus

Post Launch Assessment Review

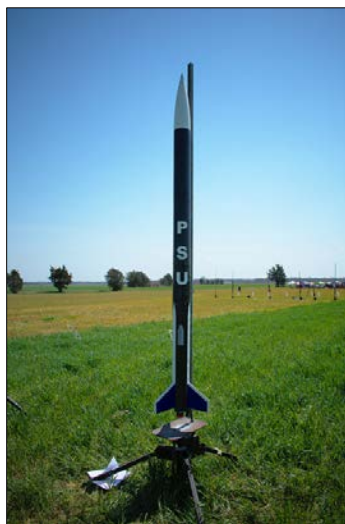
Figure 2. Constructed Final Flight Vehicle Before Competition Launch

The launch vehicle was designed to incorporate a rover payload while minimizing weight and providing sufficient strength. A diameter of 5.5 inches was chosen to give sufficient space for the payload. The overall length of the vehicle is 112 in. The dry weight of the launch vehicle is 27.75 lb, while the wet mass, which includes the motor and casing, is 36.3 lb. An OpenRocket rendering of the final flight vehicle is shown in Figure 1. The fully constructed rocket can be seen before its competition flight in Figure 2.

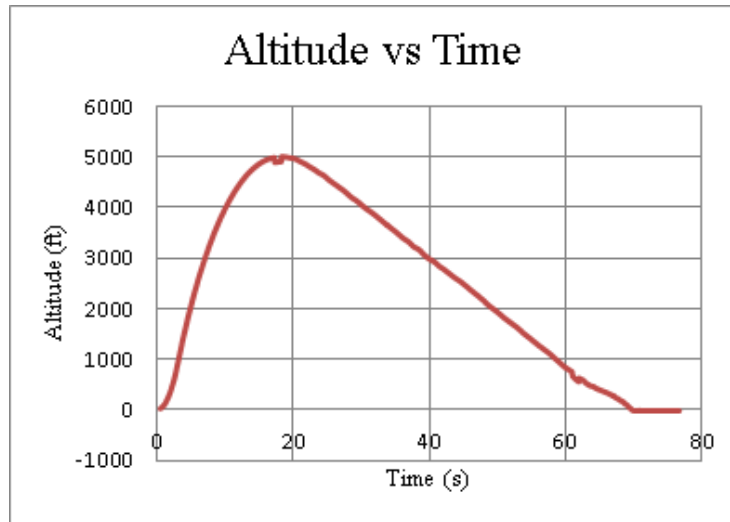
Figure 3 represents the data of altitude versus time from competition flight. The launch vehicle achieved a max velocity of 5008 ft during competition launch.

Figure 3. Altitude vs. Time Plot for Competition Launch

Due to high speed winds averaging 15 mph, the vehicle was launched into the high crosswinds to ensure the rocket drifted onto the designated land. The simulation result in 15 mph winds predicts a 4942 ft apogee and 685 m/s max velocity. The actual apogee from the flight was 5008 ft with a max velocity of 721 m/s. There is a 66 ft difference between apogee predictions and results, and a 36 m/s difference between predicted max velocity and actual max velocity. This is due to the variable winds on launch day which may not have been exactly 15 mph during the rockets 15 second ascent time along with the two degree launch angle the rocket was launched at.

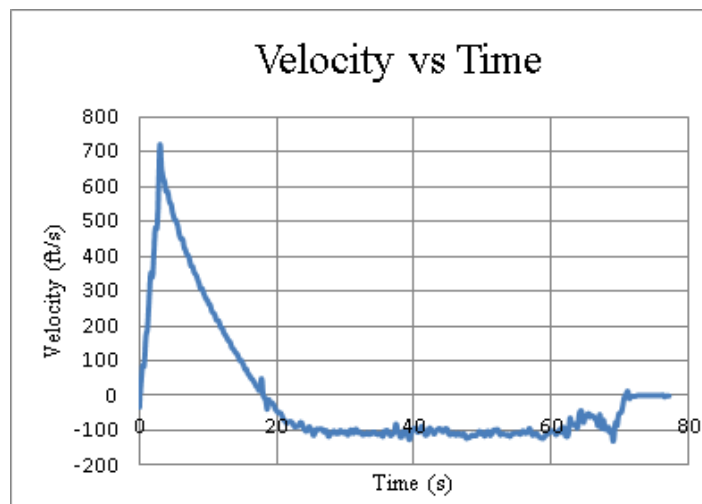
Figure 4 represents the data of velocity versus time from competition flight. The launch vehicle achieved a max velocity of 721 m/s during competition launch.

Figure 4. Velocity vs. Time Plot for Competition Launch

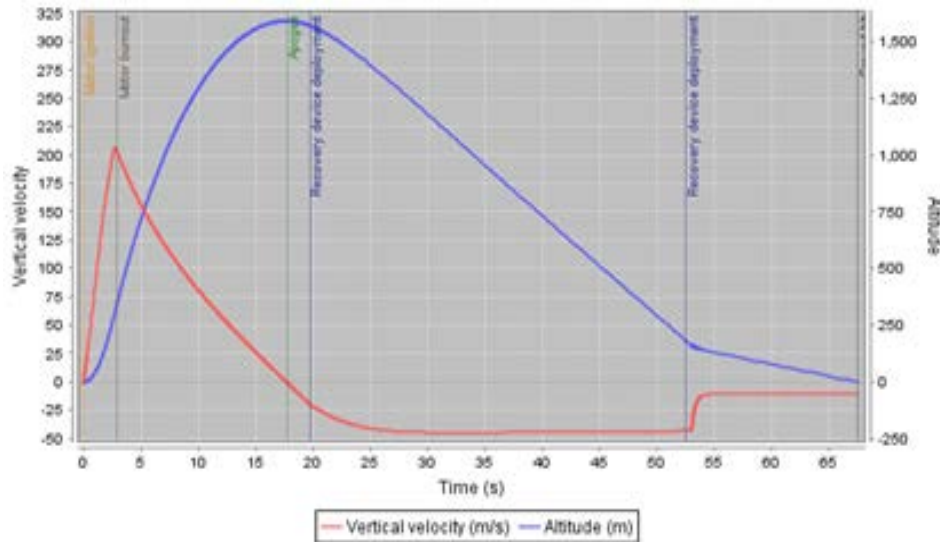
Figure 5 is the simulation result from OpenRocket. The red line represents altitude versus, time and the blue line represents velocity versus time. From the graphs shown above, the actual flight data agreed with the simulation predictions.

Figure 5. OpenRocket Altitude and Velocity Simulations for Competition Launch

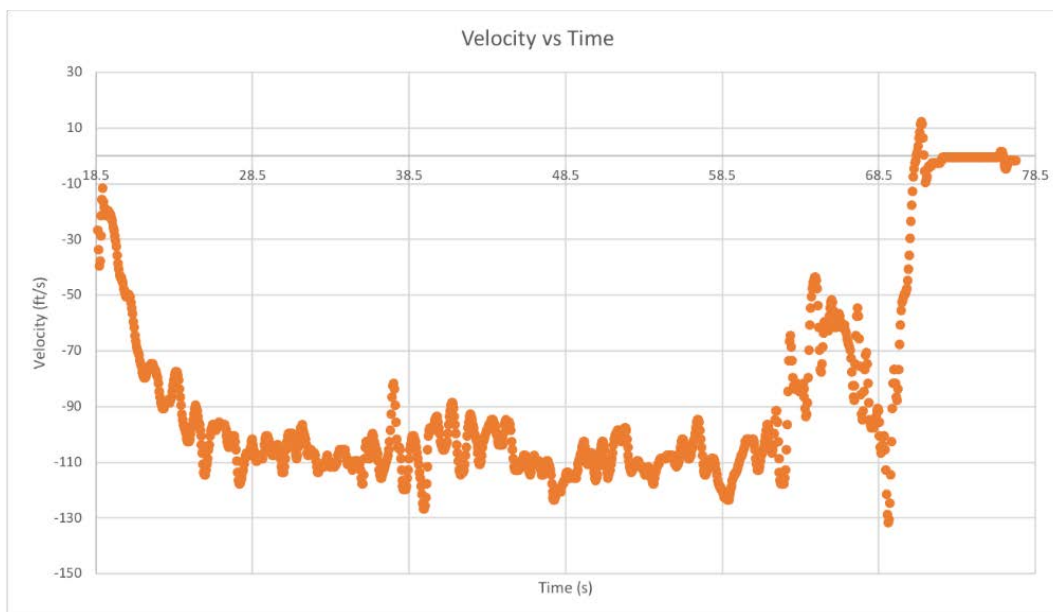
Drogue descent occurred as predicted with slight variations in descent velocity calculations. Over a period of a few seconds the descent velocity varied 30 ft/s which is characteristic of tumbling during descent. After main charges detonated, the velocity decreased to an average of 70 ft/s but with significantly more variation in velocity, which continued until contact with the ground. The velocity versus time plot of the launch vehicle during descent is shown in *Figure 7*.

Figure 7. Velocity vs. Time Plot of Competition Launch Descent

Despite launch day wind speeds averaging 15 mph, the launch vehicle only drifted 1000 ft, which is well within the acceptable range of 2500 ft. A drift distance of 1000 ft was less than the predicted 1700 ft drift distance due to a failure of main parachute deployment. The launch vehicle impacted the ground at a significantly greater speed than expected due to a main parachute deployment failure, and so the pre-flight calculation of a 61 ft-lb impact kinetic energy is significantly less than the actual kinetic energy experienced during impact. During the failed main parachute deployment, the nose cone deployment system also failed, and the nose cone separated from the rocket and freely fell as a result. This section most likely hit the ground above 150 ft/s resulting in excess of 1000 ft-lb on impact. The sections that stayed attached by shock cord also exceeded the safety requirement from their landing at near drogue descent speed. The vehicle was in good condition after impact despite main deployment failure, and there were no visible signs of damage to any avionics components.
