ArcGIS Case Study of the "Great St. Patrick's Day Flood of 1936" in Pittsburgh, PA

Wyatt McMarlin & Graham Speace

SUR 362/Dr. Dimitrios Bolkas

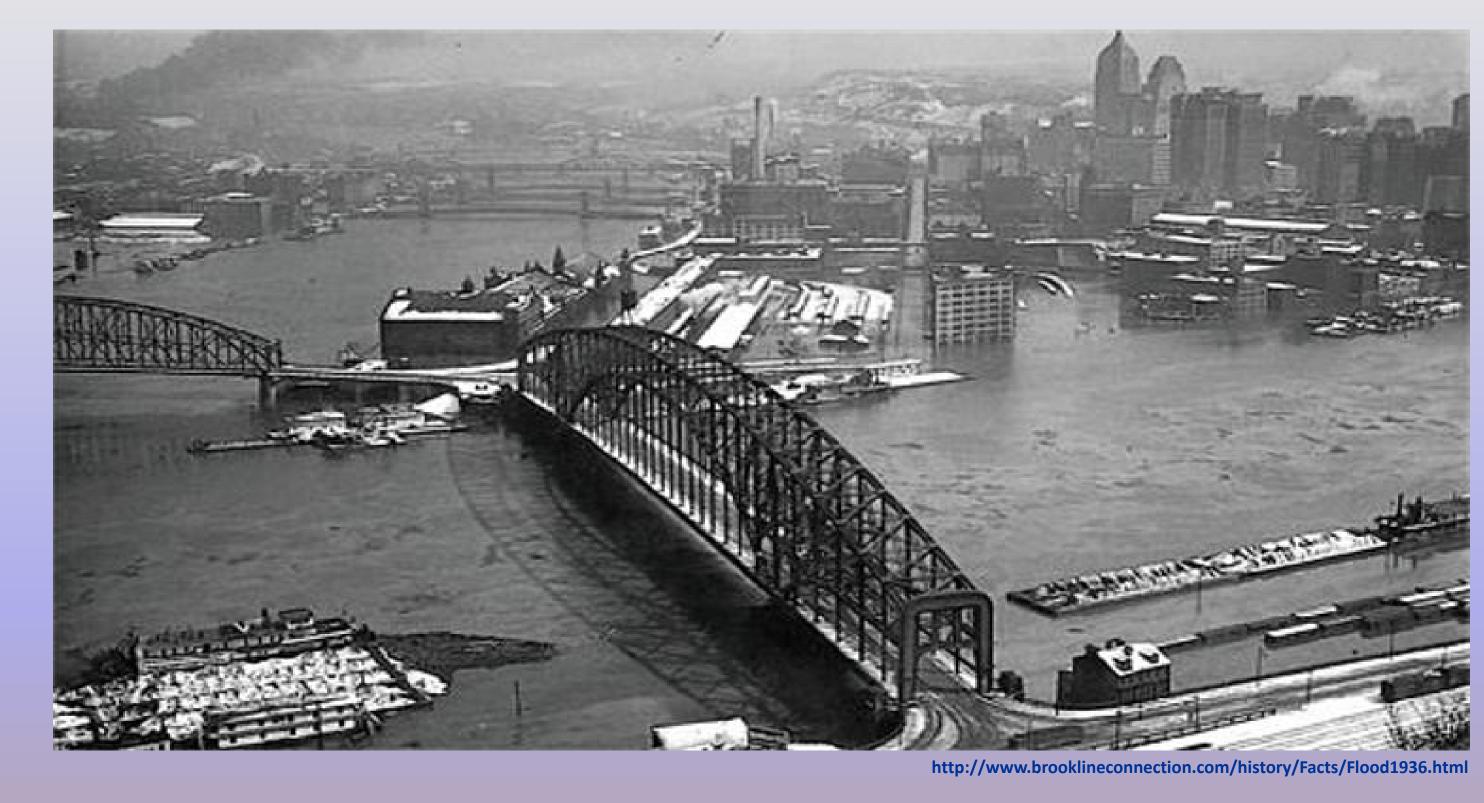
Figure 1. View from Mt. Washington showing the early stages of the flooding

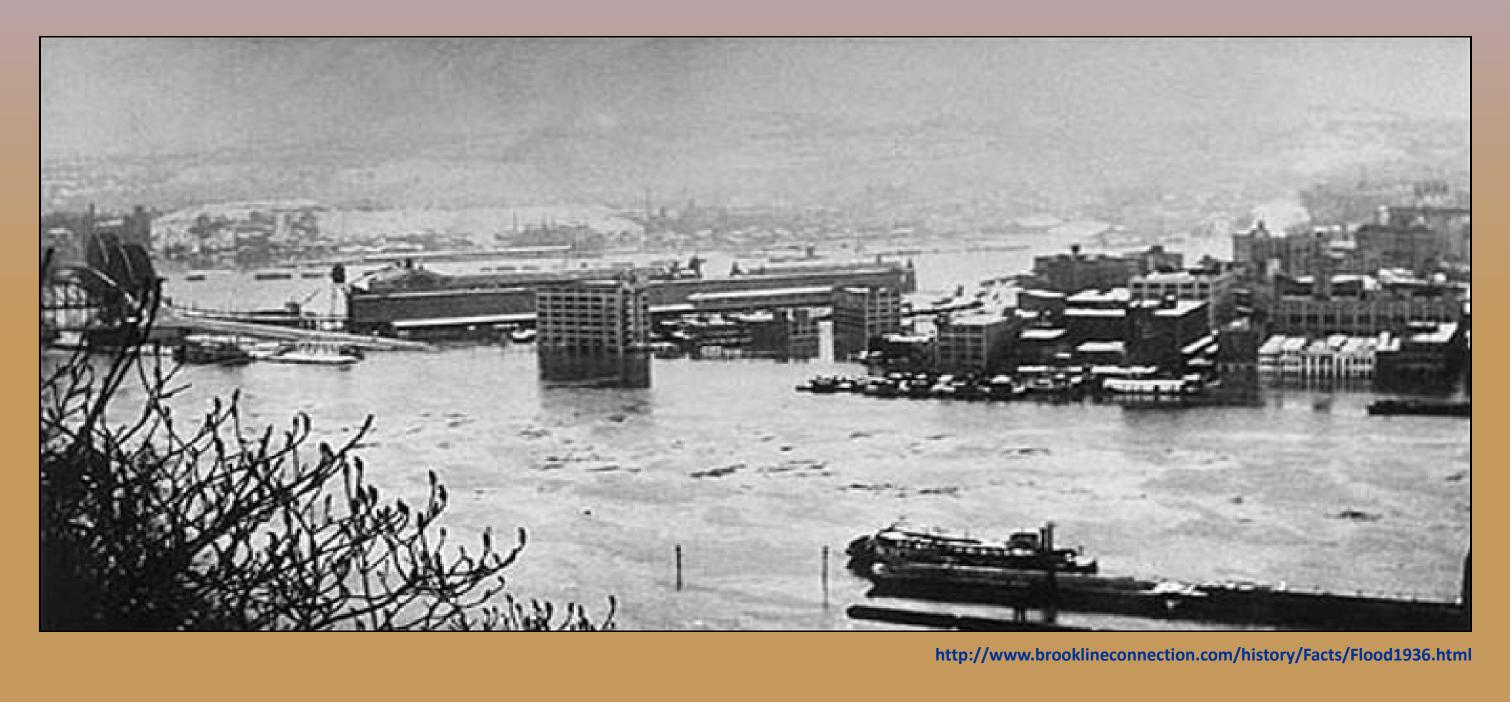
Figure 2. Water levels crested at 46 ft. (30 ft. above normal water level). Many streets in Pittsburgh's Golden Triangle were submerged by 15 ft. of water.

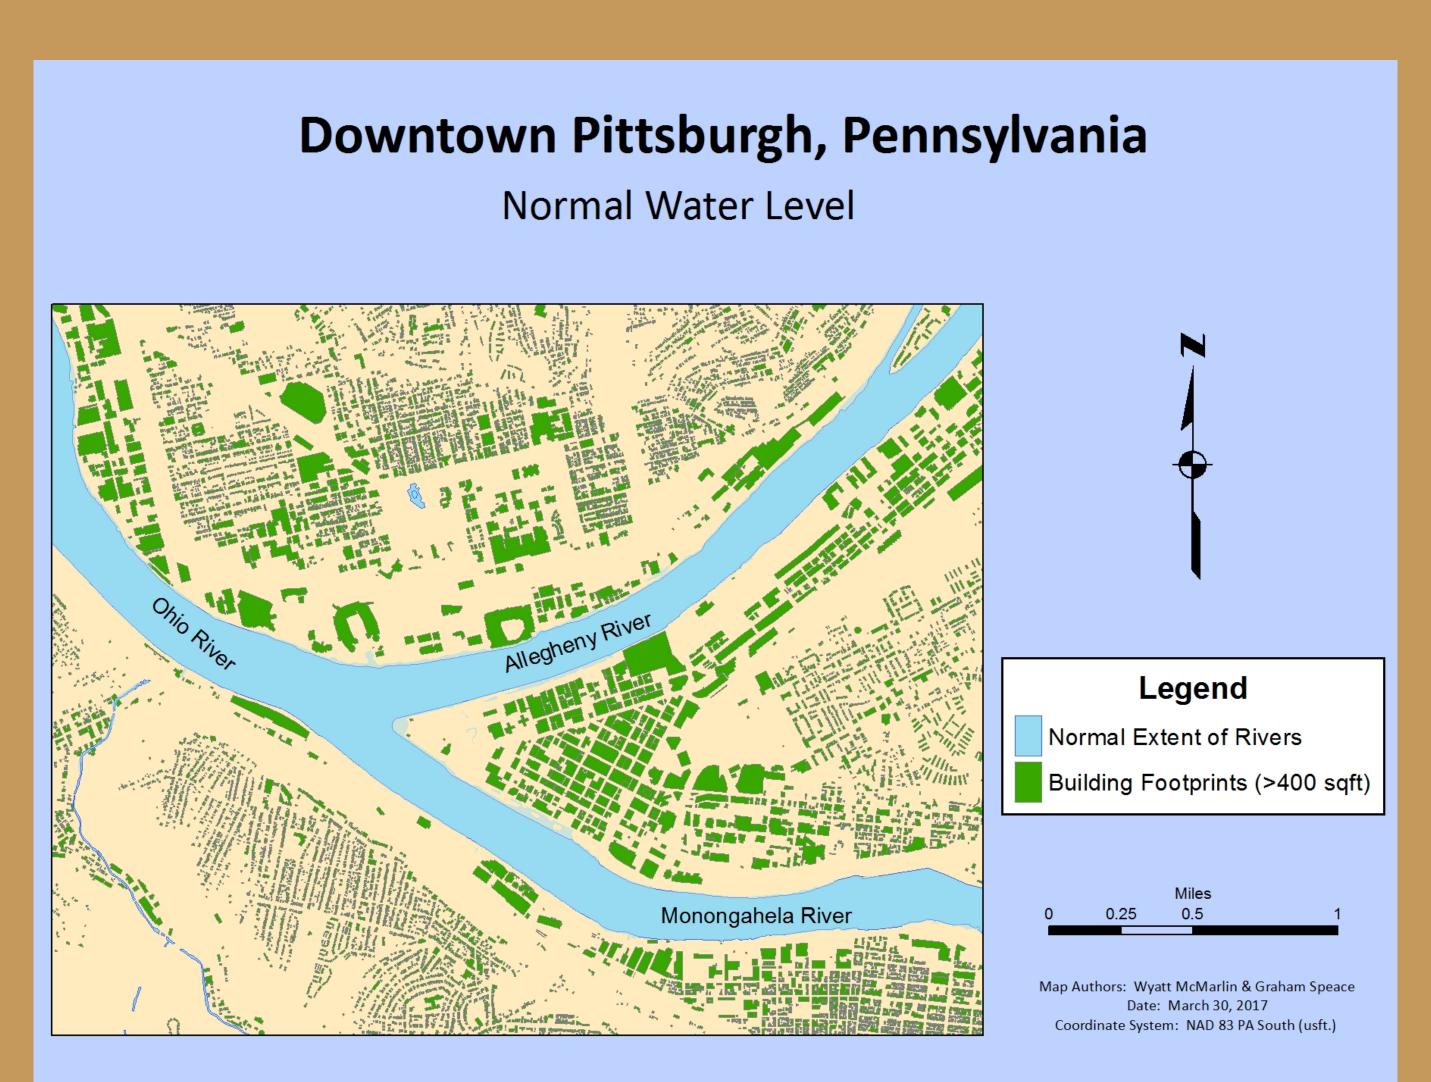
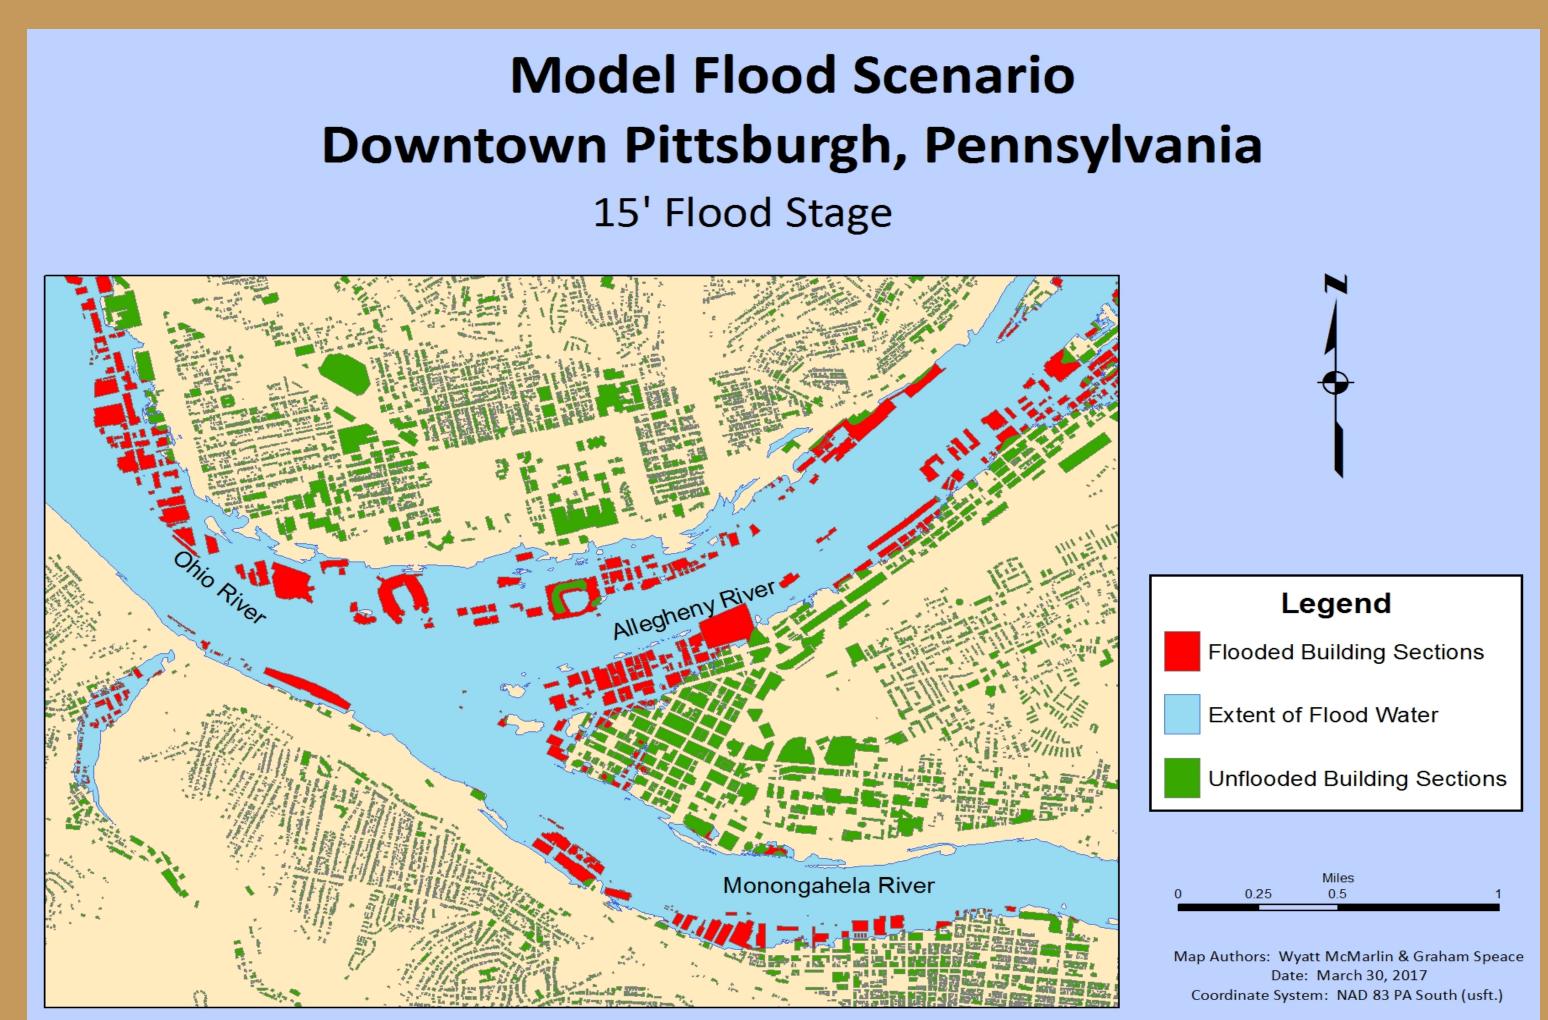
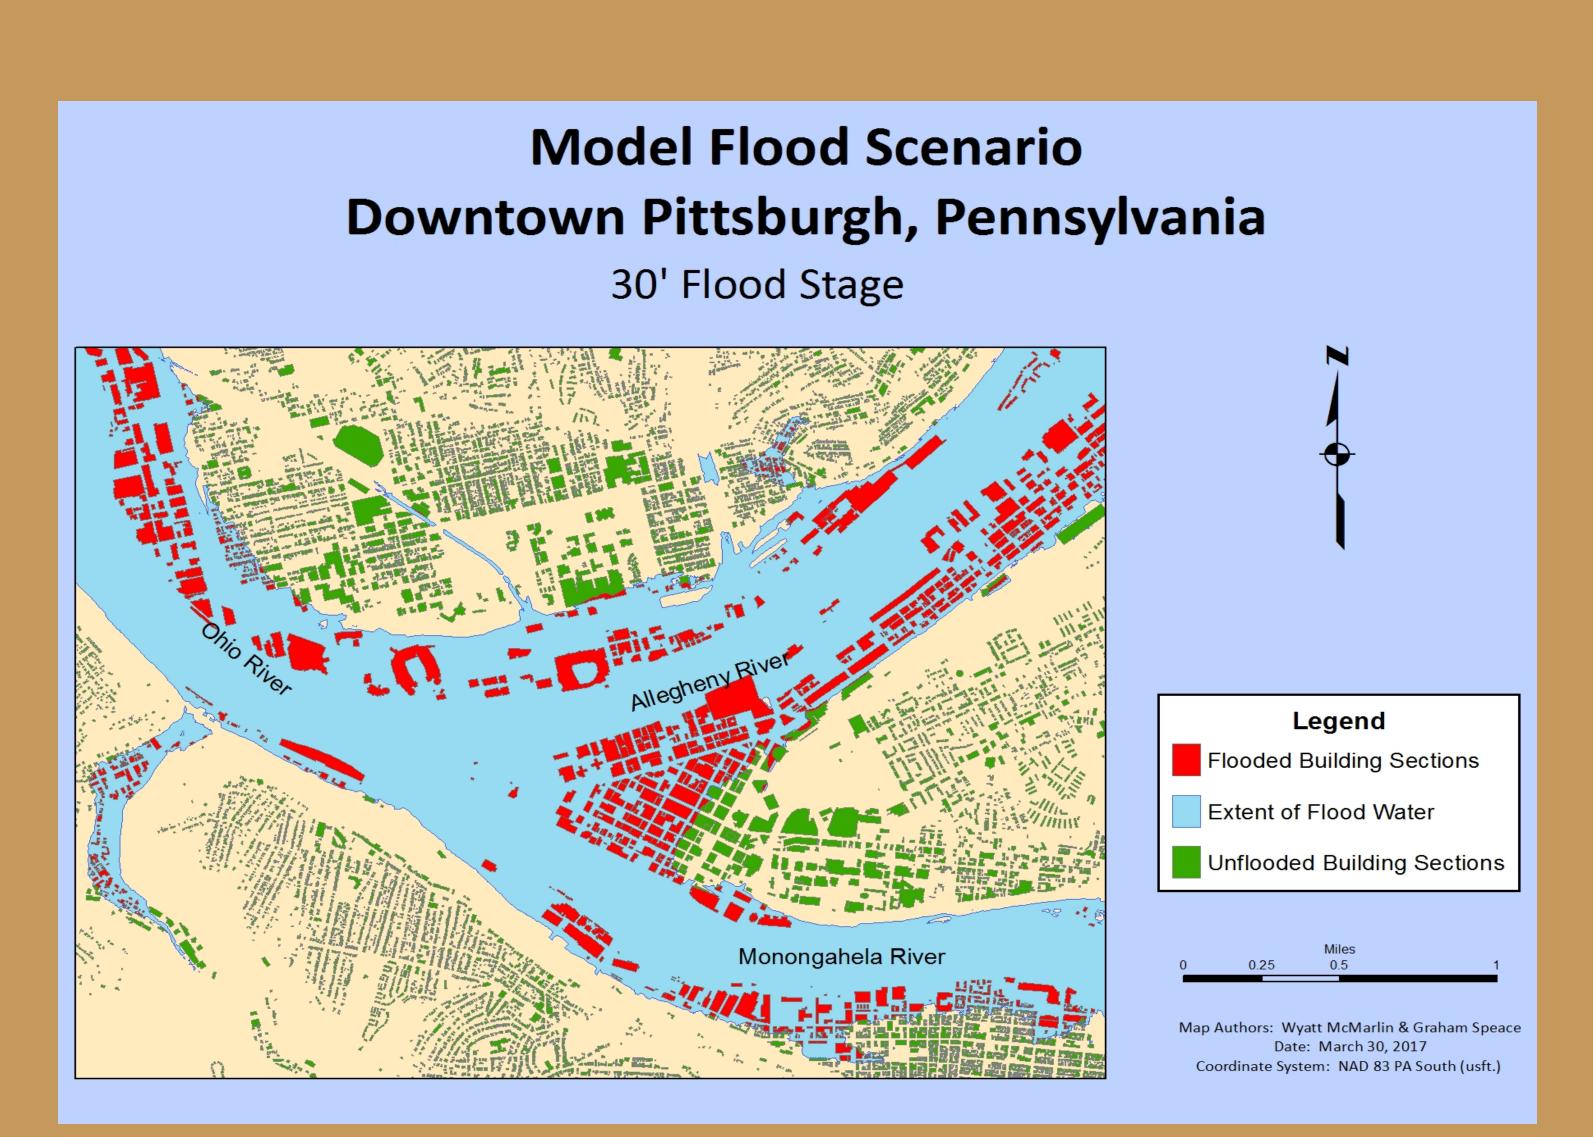
Modeling Results

- Eyewitness accounts indicate that the flooding extended from the Point to approximately Grant Street.
- Our model produced results that closely parallel what was actually seen.
- Modeled flood waters cover the Golden Triangle from the Point to Smithfield Street (two blocks below Grant Street).

- Several different flood stages in the downtown Pittsburgh Area will be modeled using ArcGIS software.
- We aim to compare the 30' flood stage results with historical records that document the extent of the 1936 flood in Pittsburgh in order to qualitatively assess the accuracy of our flood model.
